Zebra Mussel Research

Technical Note ZMR-2-19

January 1998

Comparison of the Component-Level Performance of Anti-Zebra Mussel Coating Systems with Research Coupon Results

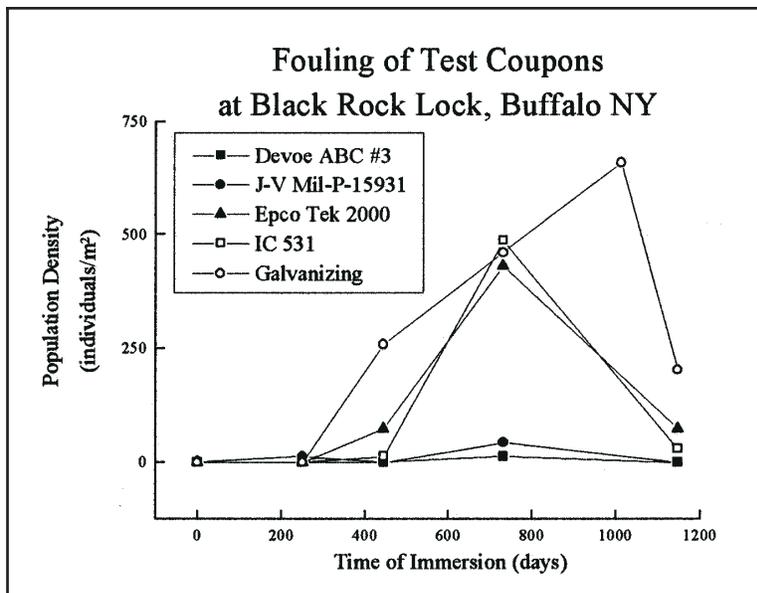
- Figure 1 plots the population densities (zebra mussels per square meter) that have infested the test coupons at Black Rock Lock over time. The two copper oxide-containing coatings (Devoe ABC No. 3 and J-V Mil-P-15931) had essentially no zebra mussels during the 3-year test. Infestations on the other coatings seem to have peaked, and are now retreating.

Figure 1. Populations density of zebra mussels over time during immersion at Black Rock Lock for copper- and zinc-bearing coatings

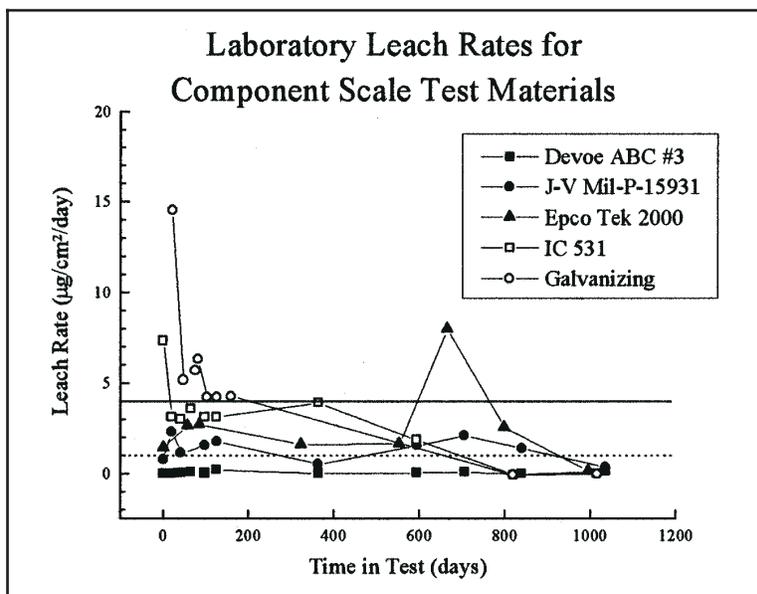
- The leach rates of the primary antifouling metal ion, as a function of the time of immersion in flowing water, for the five laboratory-tested coatings are shown in Figure 2. The minimum values of the leach rate estimated for maintaining the antifouling properties in copper- and zinc-bearing coatings are also plotted.

Figure 2. Leach rates of metal ion from copper- and zinc-bearing coatings, measured at intervals over a 3-year period. Horizontal lines indicate the estimated minimum values of leach rate for maintenance of antifouling properties in coatings (dashed line = copper; solid line = zinc-bearing coating)

As laboratory zinc leach rates have fallen, the infestation density has risen at Black Rock Lock. The bars on the trash racks at Markland Lock and Dam have not been coated long enough for the leach rates to have diminished significantly. It is anticipated that the use of thermal-sprayed zinc or zinc alloy materials would work similarly to the inorganic zinc material. These materials might be more abrasion resistant, adhere better, and provide better corrosion inhibition for a longer period.
