FINAL REPORT

**Marine Endangered Species Monitoring Program
US Army Corps of Engineers
Galveston District**

**Maintenance Dredging
Aransas Pass Entrance Channel**

Dates: 09 April - 07 July 2003

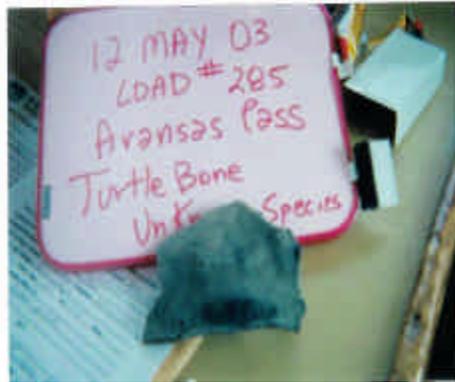
Incident #3
Aransas Pass Entrance Channel
12 May 2003, Load #285
Unknown

Incident 3 (load #285, on 12 May 03), incident 5 (load #328, on 18 May 03), incident 6 (load #352 on 20 May 03), and incident 8 (load #364 on 21 May 03) were identified as old bone fragments. The fragments observed were weathered and discolored. The species of incident 7 (load #352 on 20 May 03) was unknown. The plastron, flipper, and neck were intact by old deteriorated connective tissue with no distinguishable characteristics. Proper incident reports were completed and faxed to NMFS (Appendix 1).

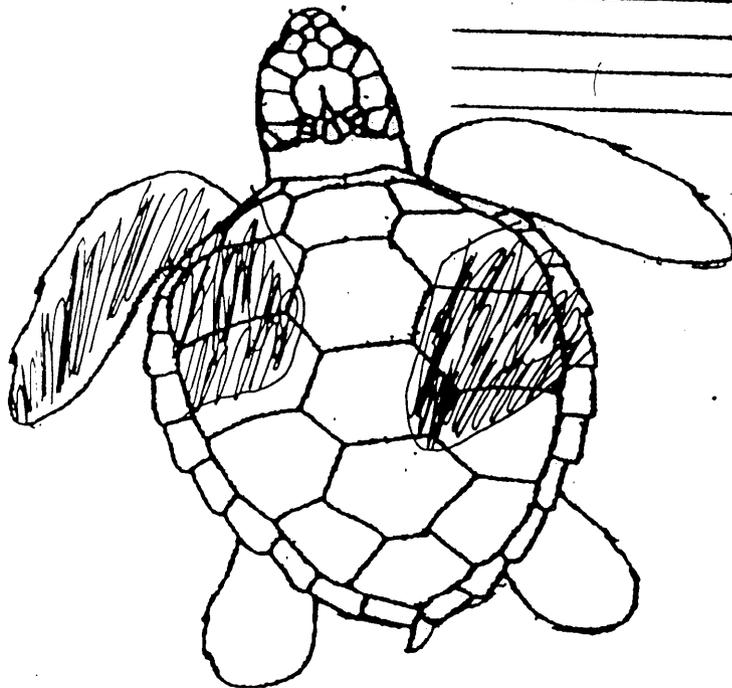
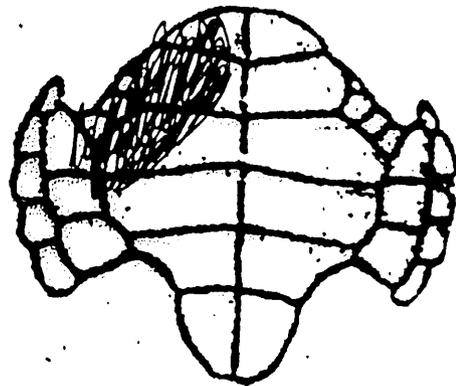
Condition of specimen(s) sampled Carapace broken, left front flipper torn off. Entire carcass recovered

Comments Left flipper missing;
Carapace cracked

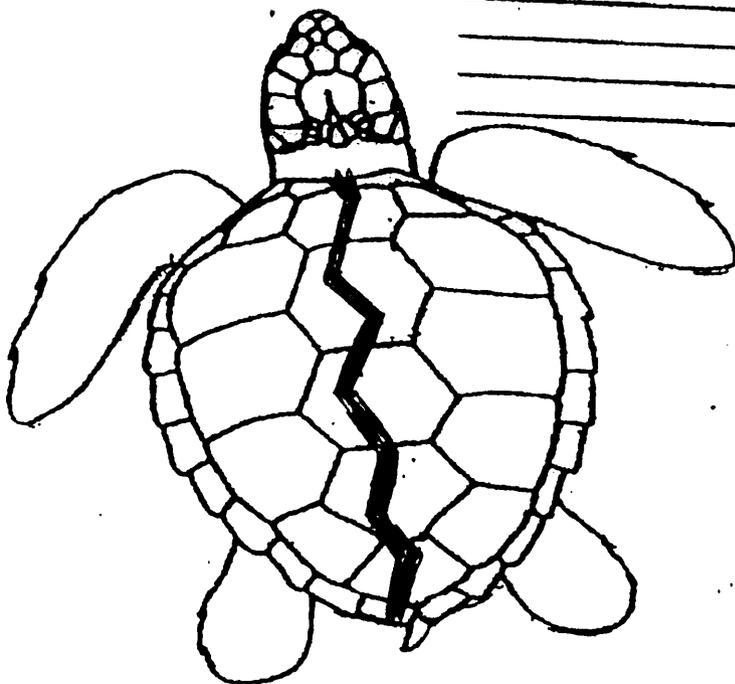
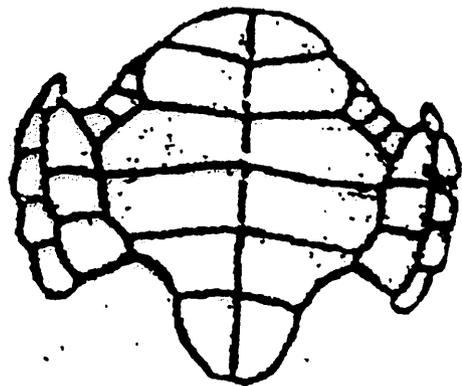
Condition of specimen(s) sampled good condition; no head injuries; no

flipper injuries. Caught in right side of draghead. Carapace

cracked down middle; found some intestines in lander + piece in

Comments Juvenile loggerhead was
intact. No visible cuts on head.
Flippers were also intact; no
tags were seen. Carapace
was folded up down the
center.

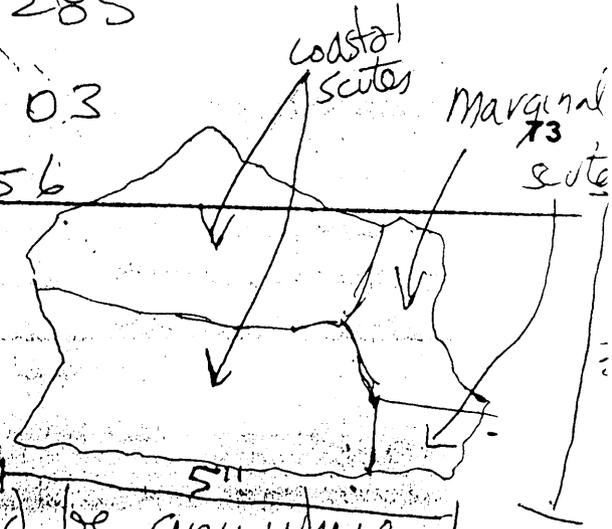
LOAN # 285

Condition of specimen(s) sampled bone not scutes

just indentation to show where scutes lay.

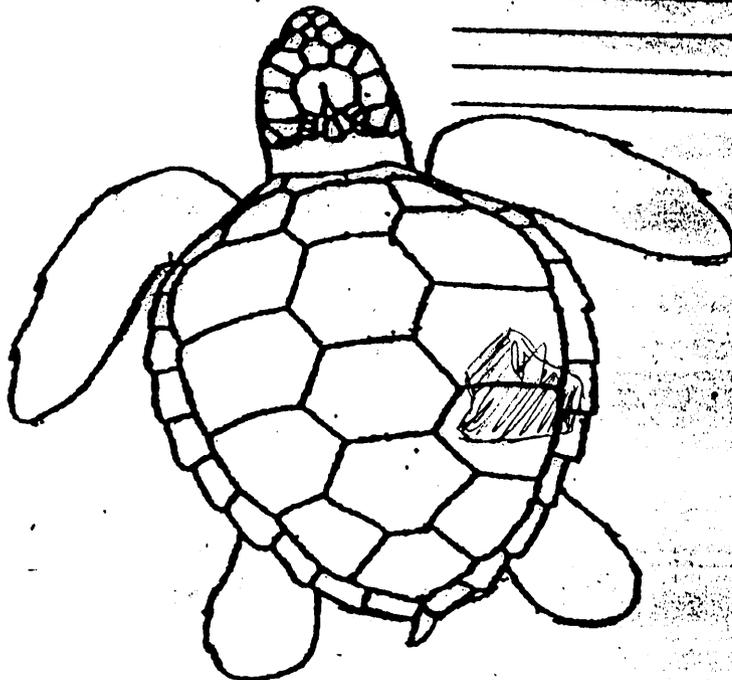
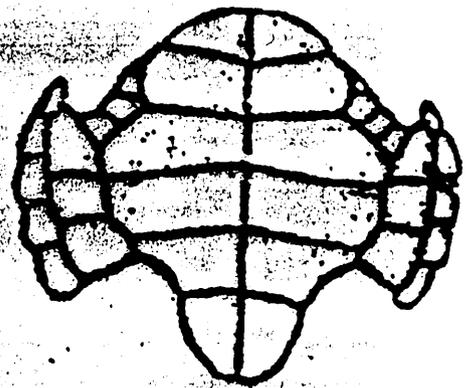
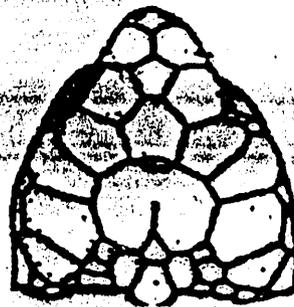
Comments could be anywhere
on the carapace, I can't
determine.

No scute just indentation
of where scute would fall
if there were scutes

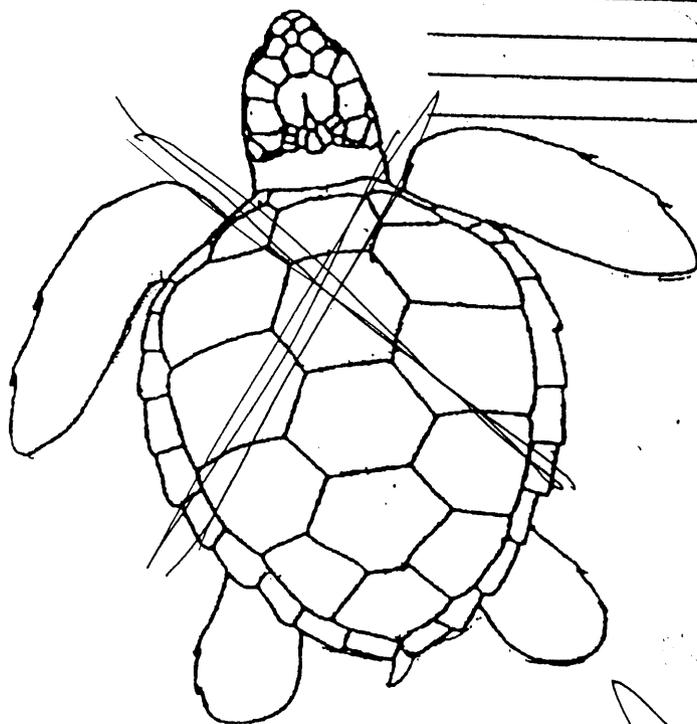
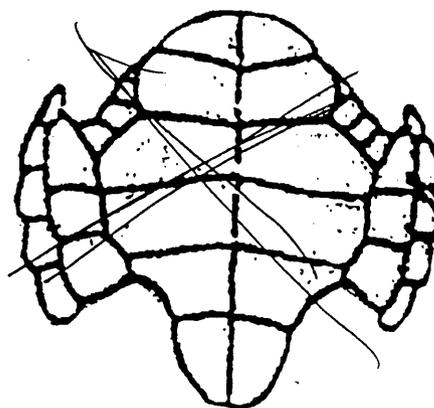
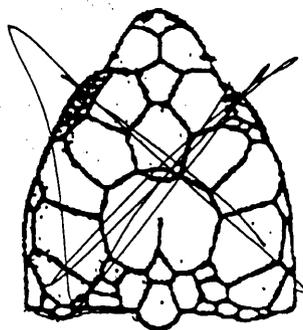
Condition of specimen(s) sampled _____
OLD & WEATHERED BONE
BLACKENED WITH AGE; WORN/ERODED @ EDGES

AGED & WEATHERED
HUMERUS
* NOT A FRESH TAKE *

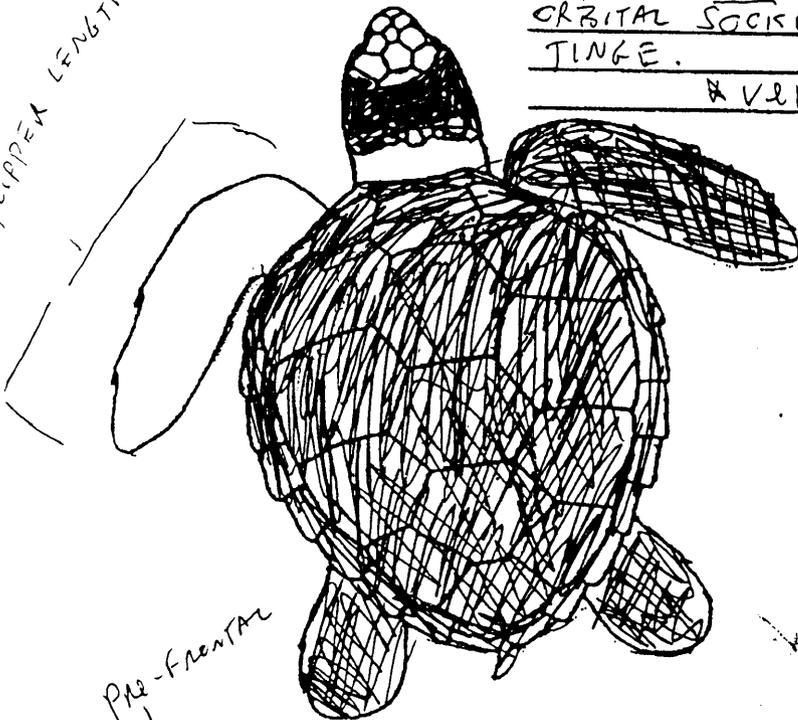
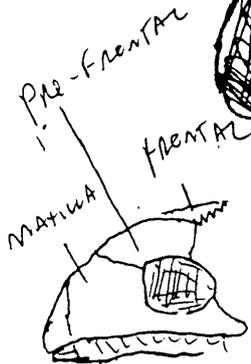
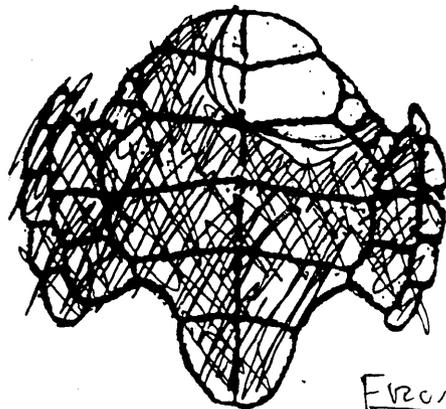
Comments ONE FRONT FLIPPER
(PROBABLY LEFT) WITH ATTACHED
SKIN, MUSCLE, CONNECTIVE TISSUE.
BECKEN PLASTION BONES &
VERTEBRA FROM NECK, UPPER
PORTION OF SKULL INCLUDING
PREFRONTAL & FRONTAL BONES
BUT NOT POSTORBITAL. FRONTAL
BONE DOES NOT FORM PART OF
ORBITAL SOCKET. TISSUE GRAY W/ ORANGISH
TINTE.

A VERY STRONG ODOR OF DECAY *

FLIPPER LENGTH 39CM

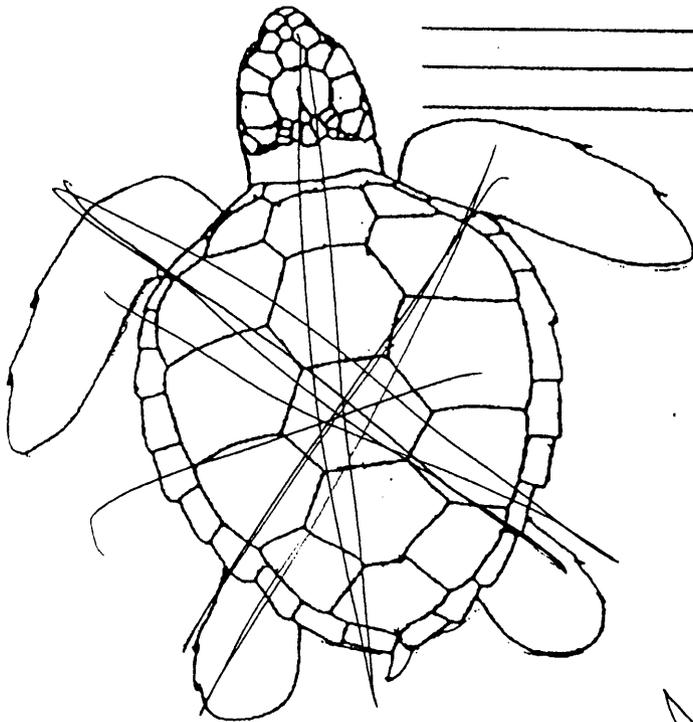
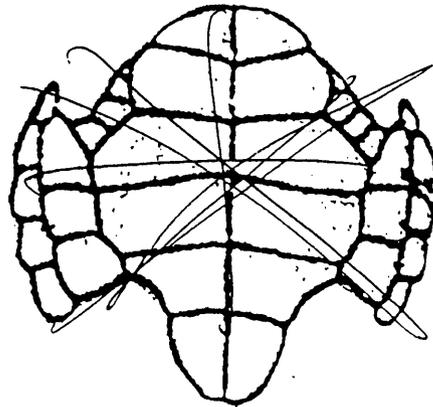
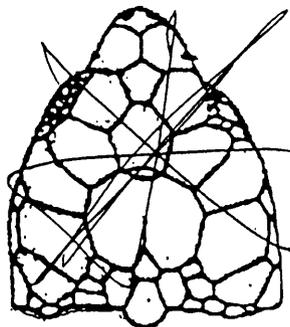
Carapace *S.L. Length _____ S.L. Width _____
 Carapace **O.C. Length _____ O.C. Width _____
 Turtle Tagged? Yes No Tag# _____ Date 5/21
 Comments: * NOT A FRESH TAKE *
OLD SEGMENT OF PLASTRON
BLACK W/ AGE, EDGES ROUNDED & WORN
SCORED BY BORING ORGANISMS
FOULED W/ BARNACLES
 Observer's Name RAY SWOIN

VERY OLD BONE
BLACK W/ AGE
BORED & FOULED
* NOT A FRESH TAKE *

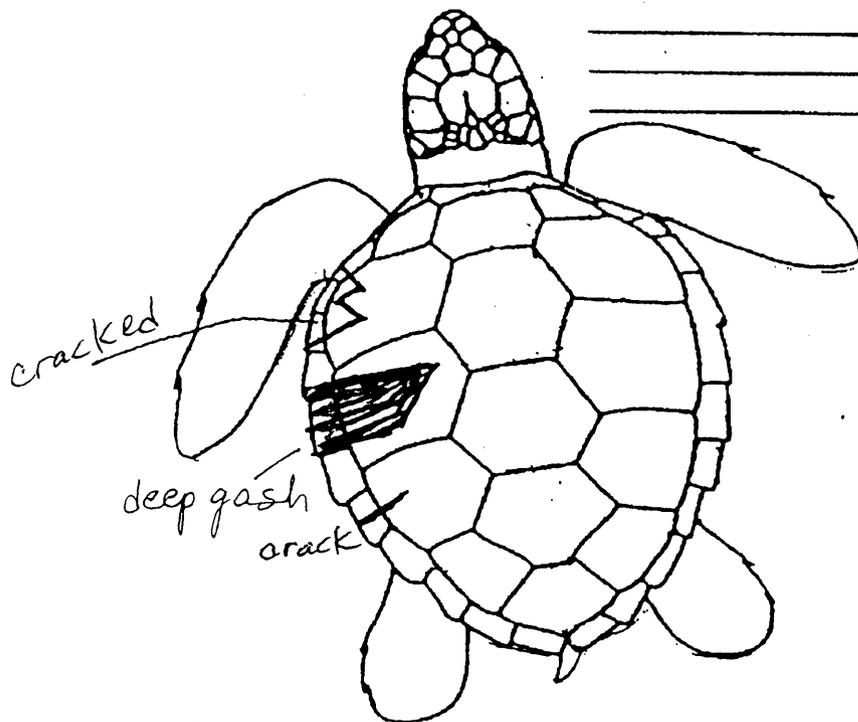
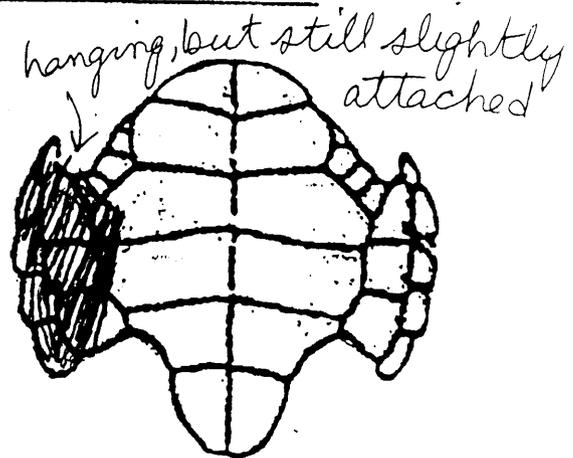
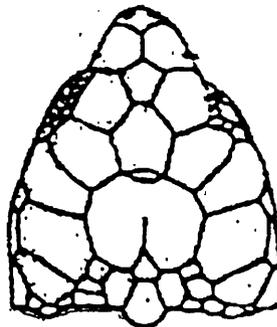
Comments Turtle still had reflexes
when first brought out of
drag arm. Large gash on
left side through plastron
and carapace. Fresh
blood coming out of wound.
Intestines protruding
from wound & some found
in lander.

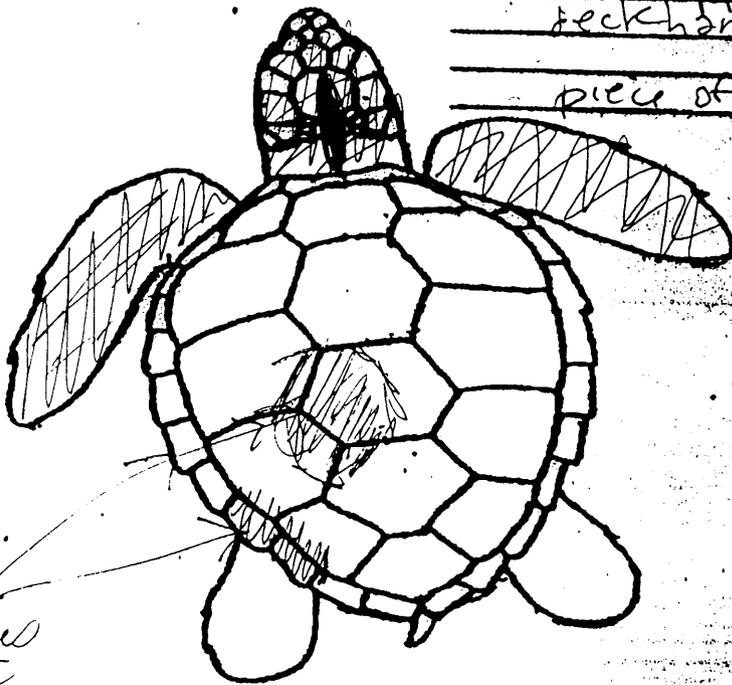
yellow skin, skin intact,
skuffed off in mid skull.
eyes sunken in. no smell
muscle still tight on bone.
piece of carapace, skull
still intact, orange brown.
- cut into flesh at neck, pink, no bleeding.
back flaps also witnessed by
deckhand, but misplaced.
piece of plastron

piece of carapace:
location unknown
only hypothetical.

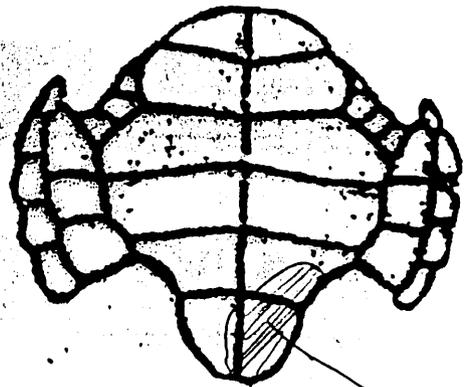
piece of plastron:
location unknown
