DREDGED MATERIAL RESEARCH PROGRAM

MISCELLANEOUS PAPER D-77-2

FIELD STUDY TO DETERMINE THE FEASIBILITY OF ELECTRO-OSMOTIC DEWATERING OF DREDGED MATERIAL

November 1977

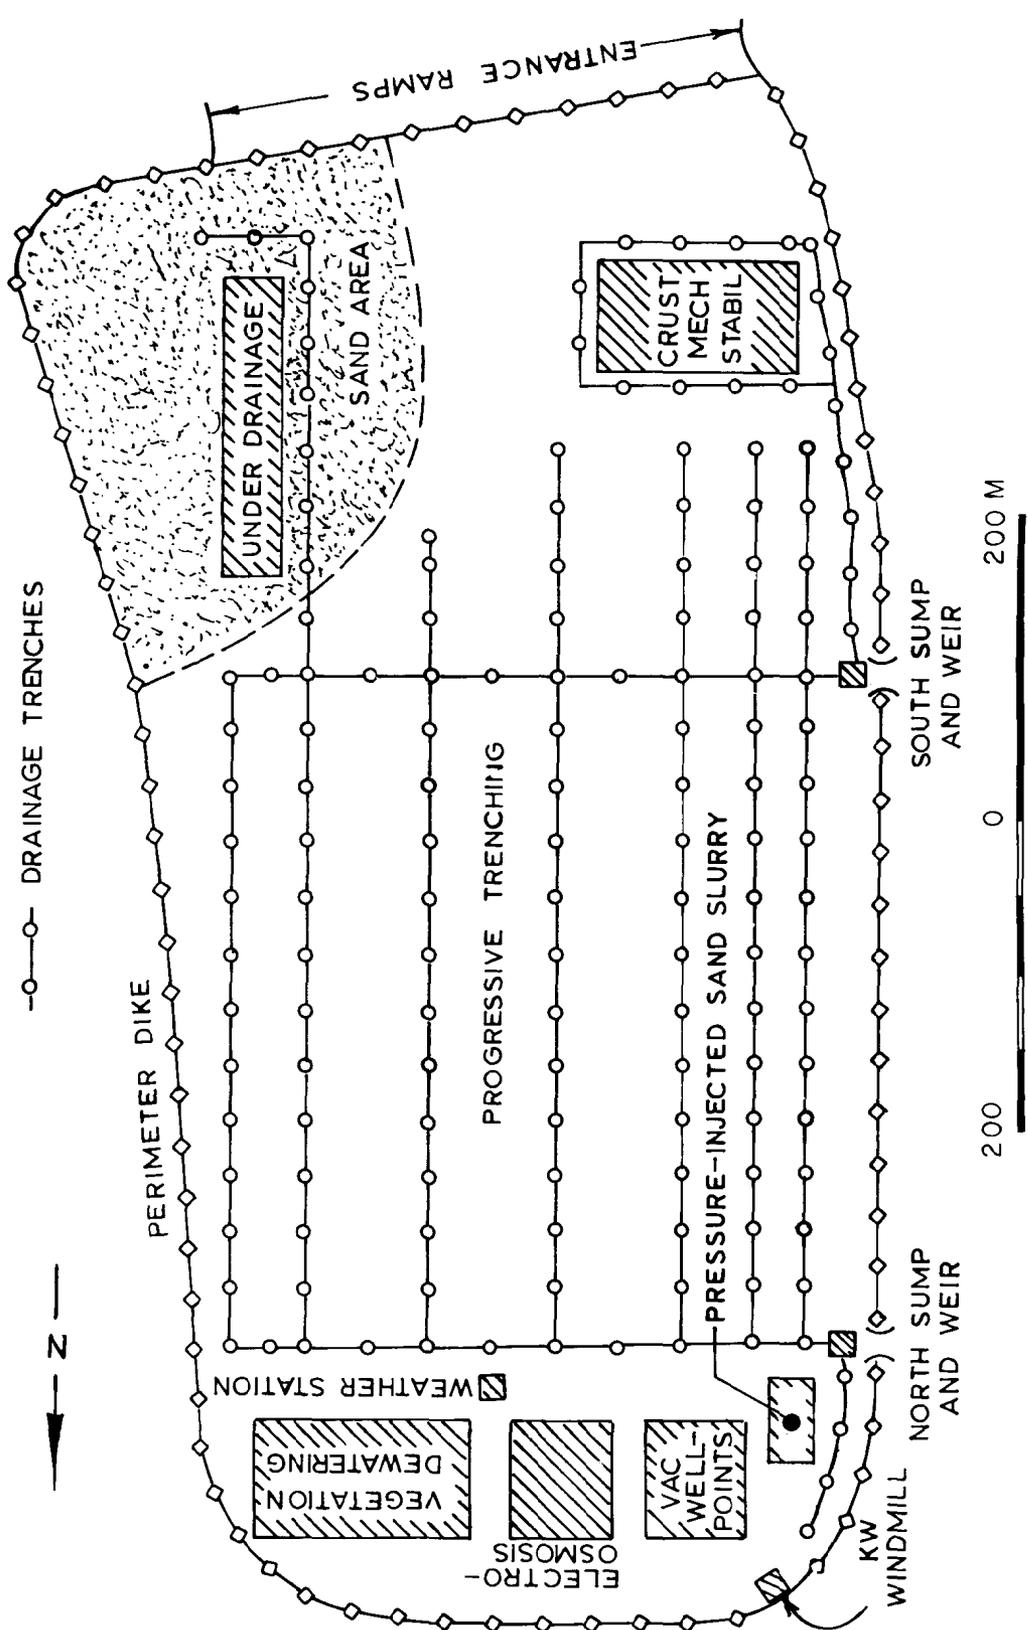
3. A diagram of the test site is shown in Figure 1. This diagram shows the configuration of the disposal site and the location of the electro-osmosis site in relation to other dewatering techniques investigated during the same period. Figure 2 is an aerial photograph

Figure 1. Dredged material dewatering field demonstrations
 Upper Polecat Bay Disposal Area, USAE District, Mobile

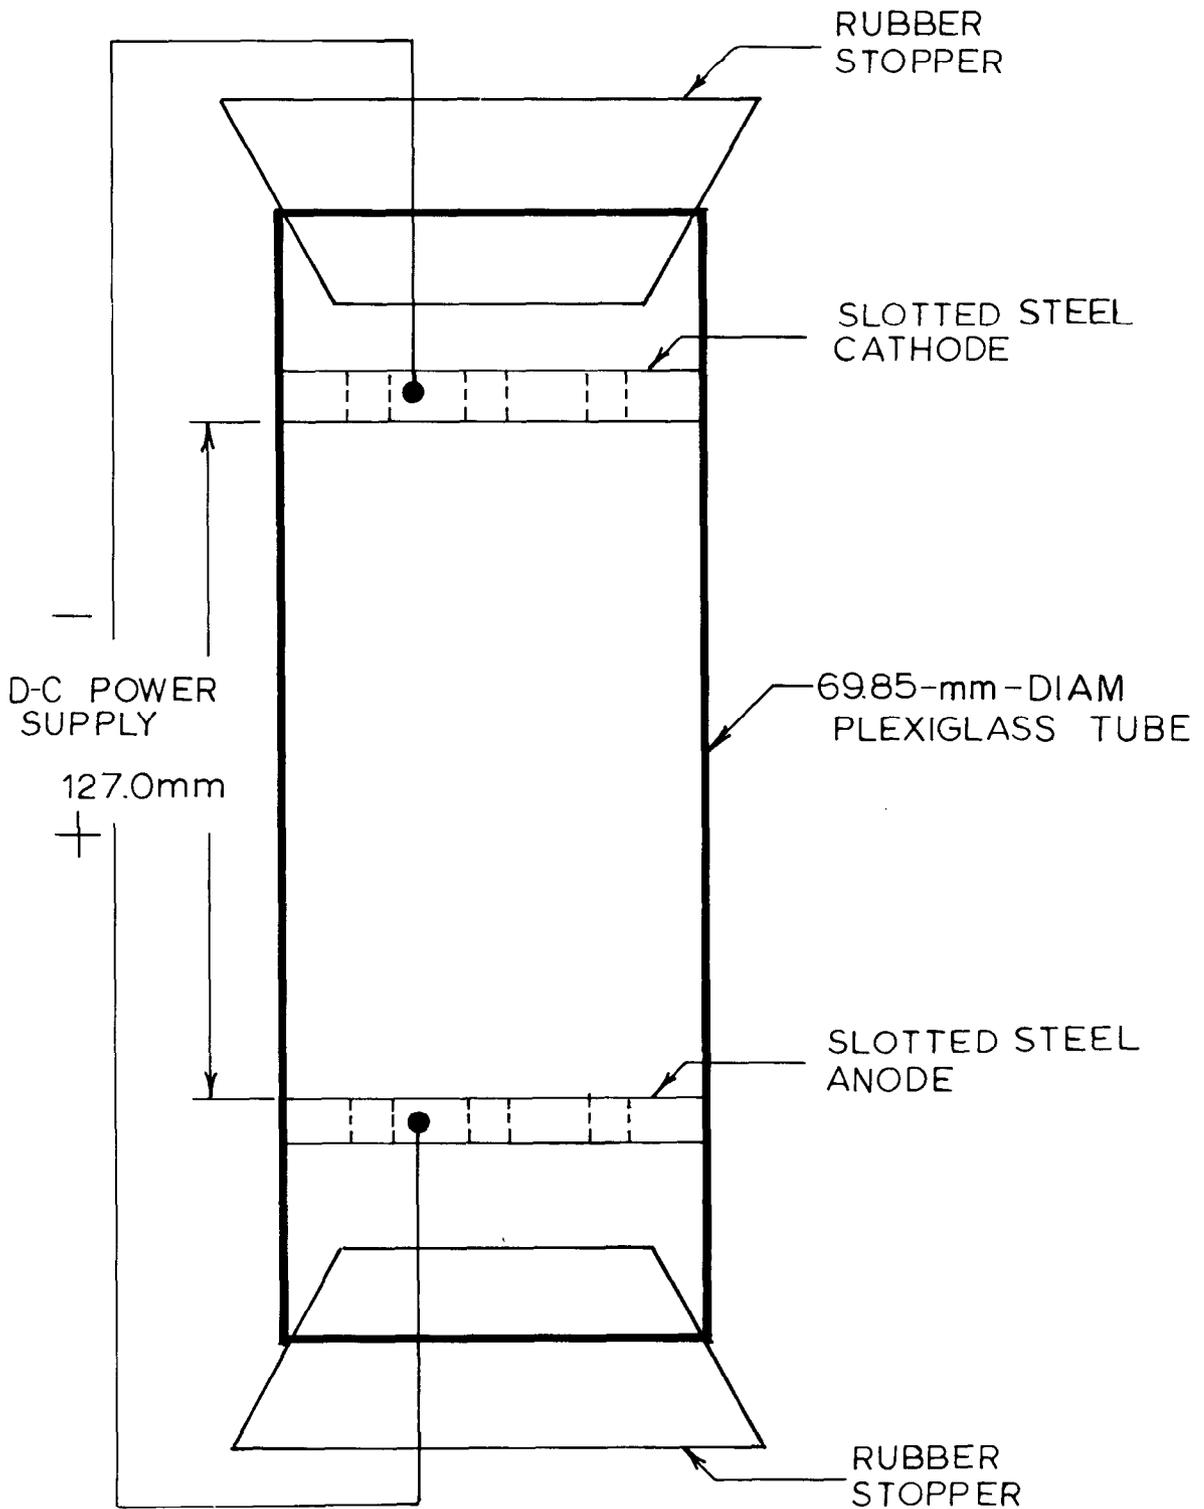
19. Top- and bottom-drain testing was conducted to determine if flow direction had a significant influence upon electro-osmotic dewatering. A typical apparatus is shown in Figure 3. Water was removed from half of the samples through bottom drains. In these,

Figure 3. Typical tube testing apparatus

an anode was placed on top of the sample and a cathode on the bottom. Water migrated to the cathode and, from there, water flowed by gravity through a glass tube into a collection flask. The cathode and anode were reversed in the remaining tubes, and water flowed upward and collected on top of the tube samples. This water was removed by pipet. A summary of the test results is shown in Table 1.

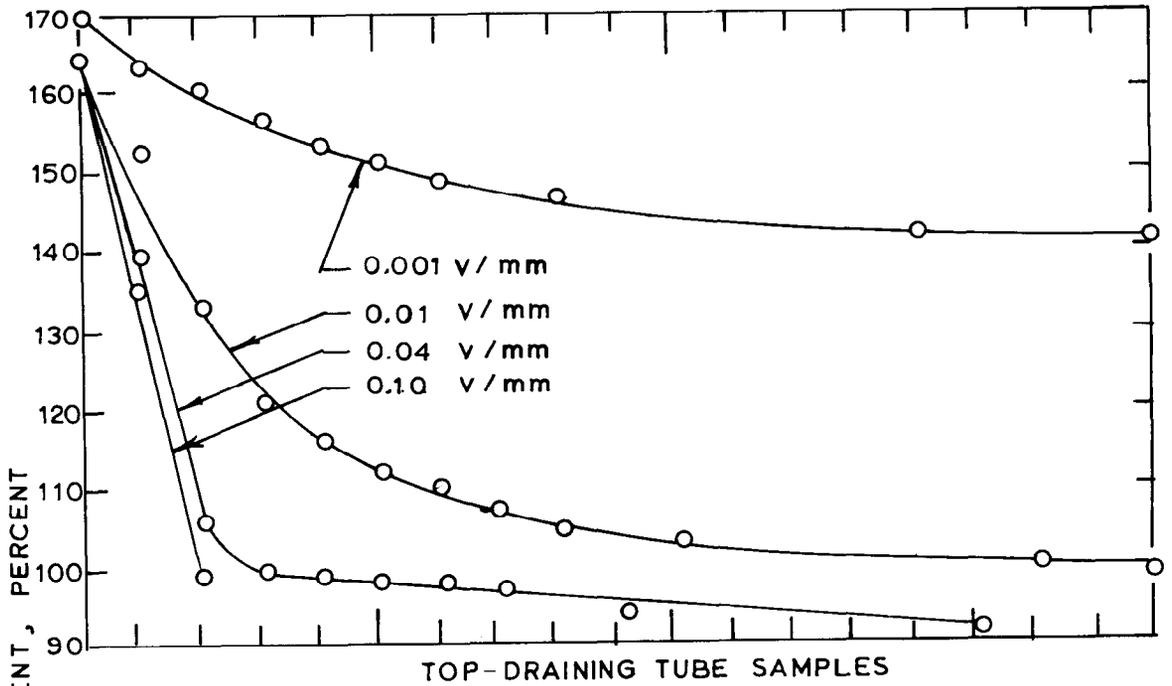
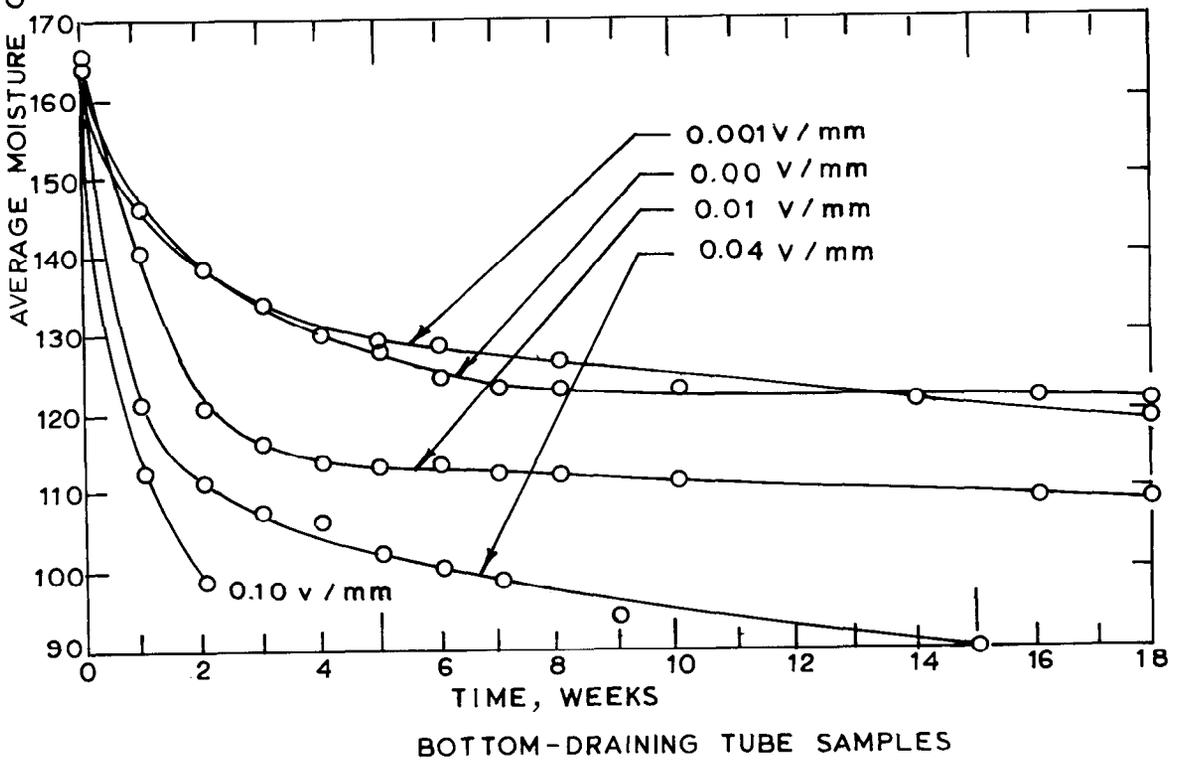
21. The results of tube tests conducted on top-draining samples are shown in Figure 4. Figure 4 shows weekly average moisture contents as a function of time and applied voltage gradient. The curves show that moisture content generally declines exponentially at all voltage gradients, i.e., the rate of dewatering decreases with time. Voltage gradient has a marked effect upon the rate of dewatering and may or may not affect final moisture content. During the first two weeks of dewatering, the moisture contents decreased from 164 to 132% at a gradient of 0.01 V/mm, to 105% at 0.04 V/mm, and to 99% at 0.10 V/mm. The 0.001-V/mm sample did not lose a significant quantity of water, moisture content decreased from 172 to 160% during the first 2 weeks and to 150% after 14 weeks. The final moisture content achieved in the samples was approximately the same (100%) for gradients between 0.01 and 0.10 V/mm. At 0.10 V/mm, the result was achieved after 2 weeks. It took 3 weeks at 0.04 V/mm and about 15 weeks at 0.01 V/mm.

22. Figure 4 also shows changes in moisture content as a function of time and applied voltage gradient for bottom-draining samples. The results shown for bottom-draining samples are similar to results obtained with the top-draining samples. A series of samples was allowed to drain without the application of a current to illustrate the

Figure 4. Average moisture vs. time for top- and bottom-draining tube samples

influence of gravity on the bottom-draining samples. A comparison of these controls, 0.00-V/mm and the 0.001-V/mm data, indicates essentially no difference in results. Figure 4 shows that the rate of dewatering increases with increasing voltage and final moisture content tends to decrease somewhat with increasing voltage.

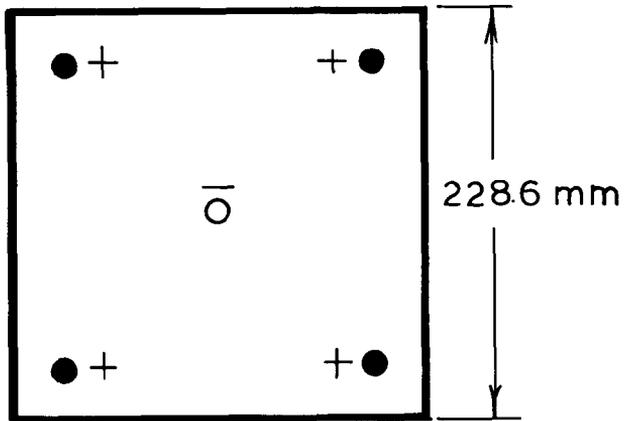
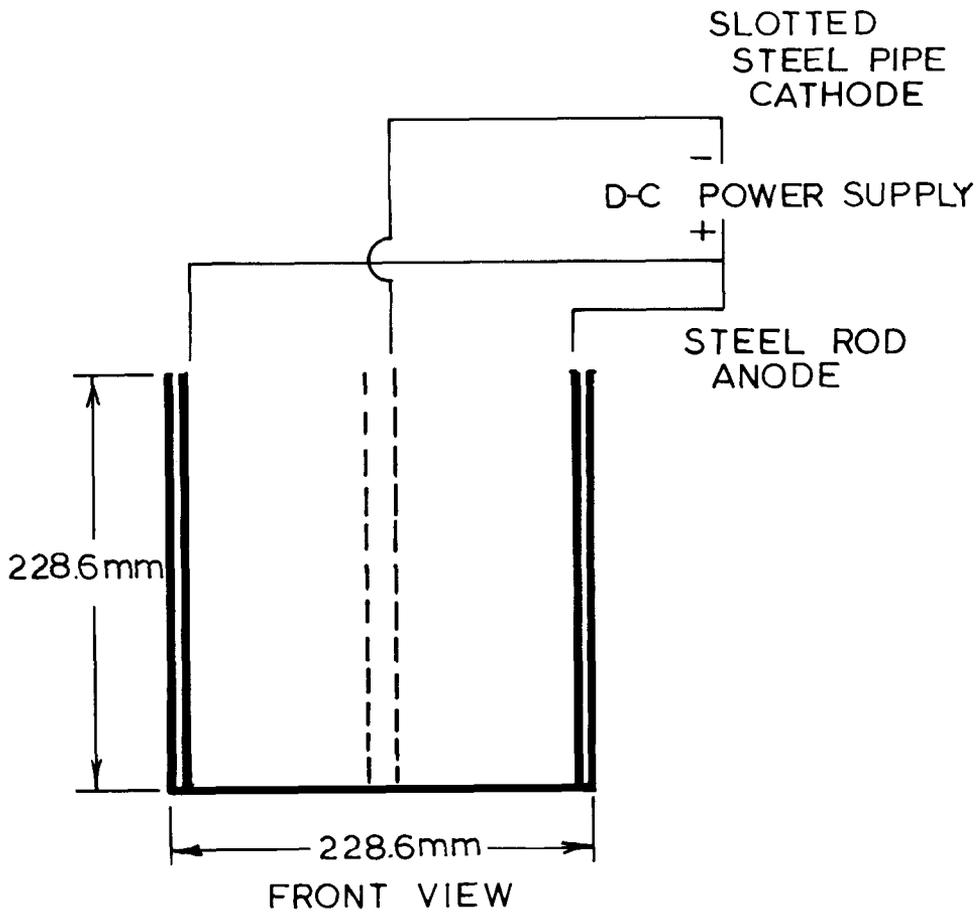
25. To model field conditions of horizontal flow to a vertical well casing, a series of box model tests were performed. The study consisted of placing soil samples of various moisture contents into 228.6 x 228.6 x 228.6 mm boxes (see Figure 5). Since the sample was well above the liquid limit, the material was literally poured into the boxes. The average initial dry density was 541.4 kg/m³ and the average initial void ratio was 3.93. The boxes were completely filled with soil and one vertical slotted steel pipe cathode was placed in

Figure 5. Box model testing apparatus

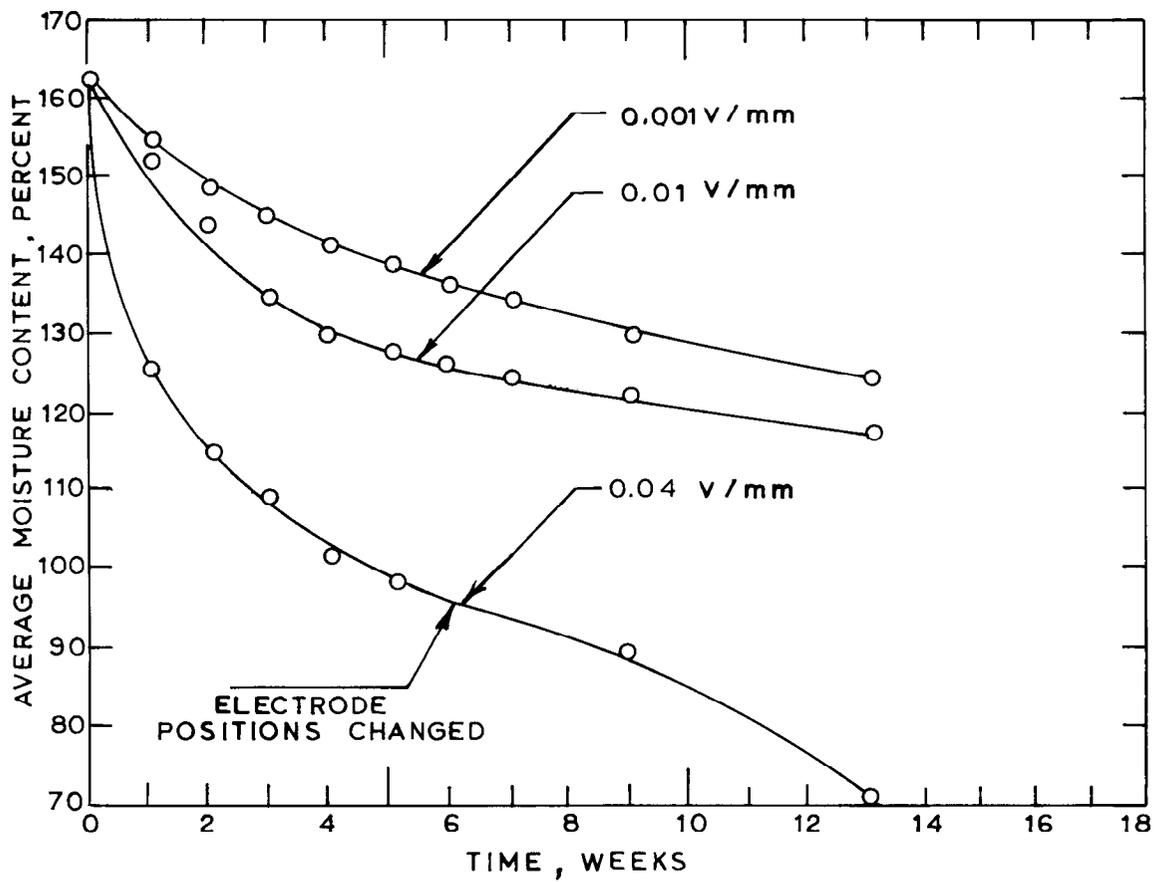
28. The results of the tests are shown in Figure 6. Figure 6 shows weekly average moisture contents as a function of time and applied voltage gradients. The curves are very similar in shape to those obtained in the tube tests. Voltage gradient was once again found to have a marked effect upon the rate of dewatering. During the first two weeks of electro-osmotic dewatering, the moisture content decreased from 162 to 114% at a gradient of 0.04 V/mm to 143% at 0.01 V/mm, and 148% at 0.001 V/mm. After 13 weeks, the sample at 0.04 V/mm had decreased to 70%. After 13 weeks, the moisture content in the sample at 0.01 V/mm was reduced to 118%, and in the sample at 0.001 V/mm the final moisture content was 125%.

Figure 6. Average moisture content vs. time for box models

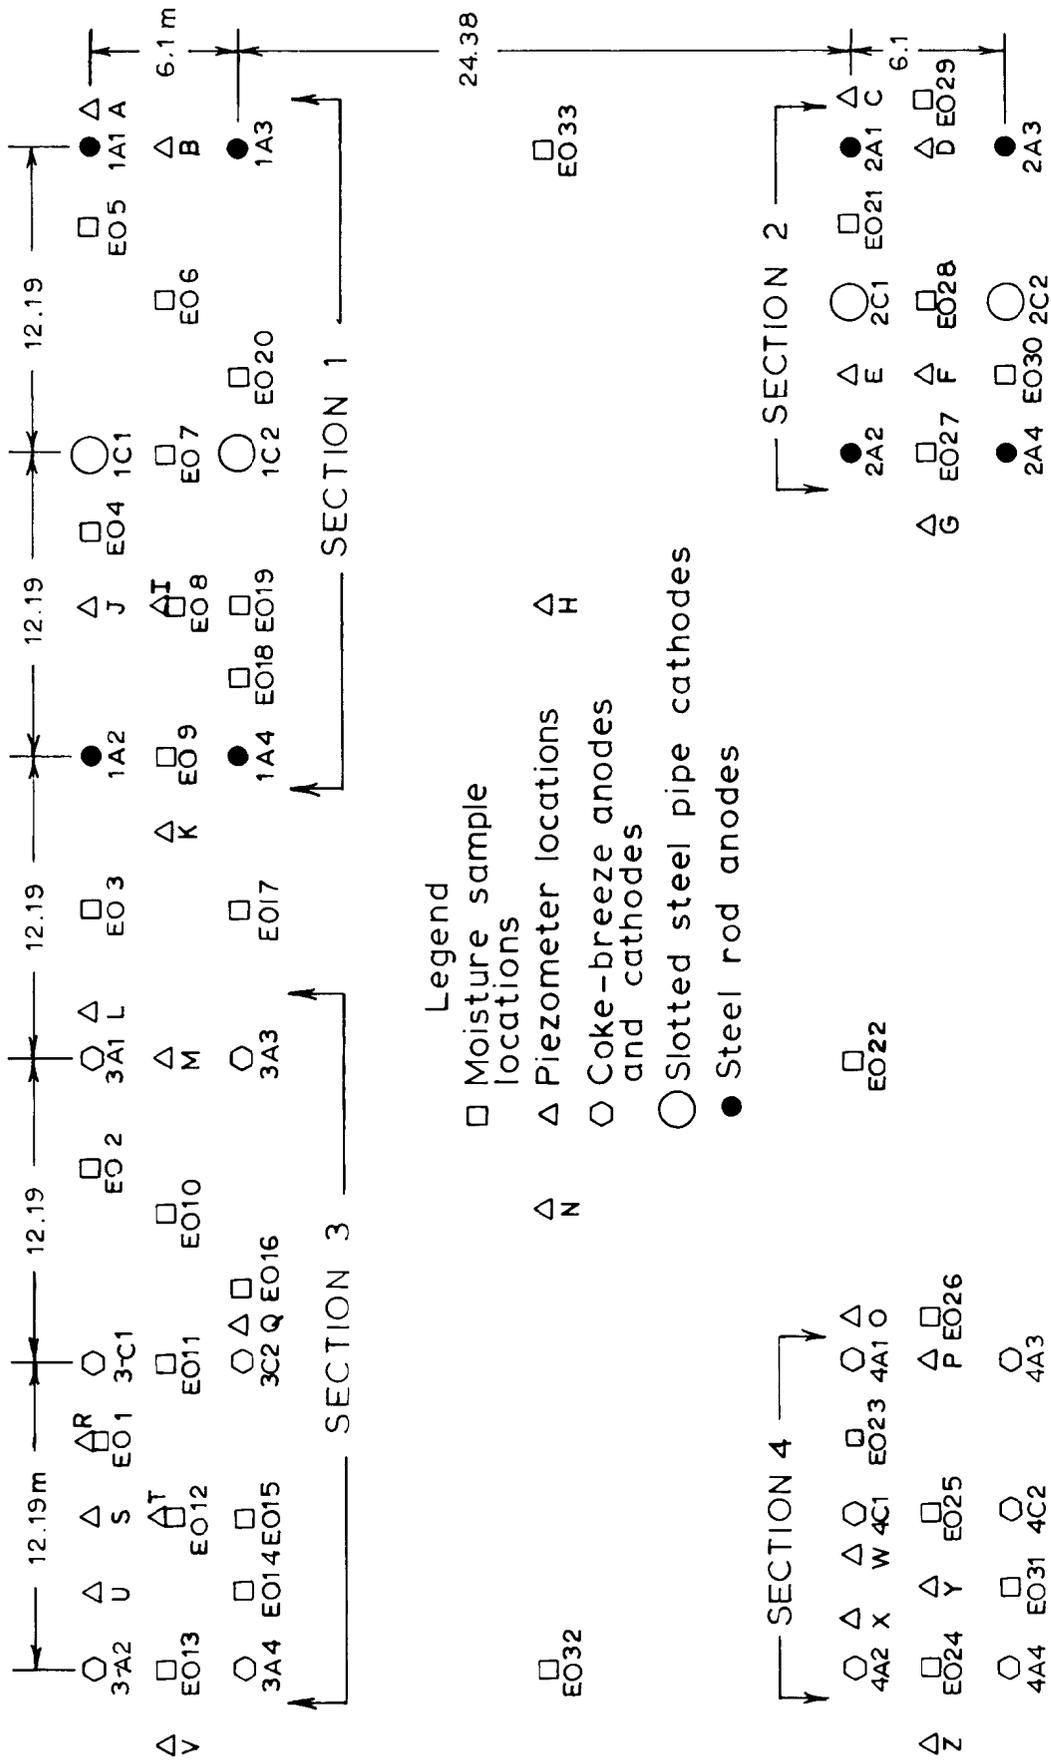
36. The test site design consisted of four experimental test sections. These sections, labeled Sections 1 through 4, are shown in Figure 7. Each test section was set sufficiently apart from the others to eliminate interference and interaction, as tests on all sections were conducted during the same time periods. Various factors were considered in the design phase of the study. These were voltage gradient, time, electrode spacing, electrode configuration, type of electrode, and methods of removing water from the cathode wells.

Figure 7. Plan view of test site showing electrode spacing and piezometer and moisture content sample locations

40. Figure 7 shows anode and cathode spacing, as well as the location of piezometer tubes and soil moisture sampling locations. Two cathodes (discharge wells) and four anodes were placed in each test section. Anodes in Sections 1 and 3 were placed 12.192 m from each cathode on opposite sides; in Sections 2 and 4, anodes were placed in a similar manner, but at a distance of 6.096 m from the cathodes.

46. A series of piezometer tubes were located throughout the four test sections. The placement of these is shown in Figure 7. The piezometers were to be used to measure the decline in water surface as dewatering progressed. A grid system of bench marks was provided to enable monitoring surface subsidence if it occurred.

56. Five series of moisture samples were taken to determine soil moisture content changes with progressive dewatering. Samples were taken at locations shown on Figure 7. Samples were taken at depths of 0.6096 - 0.9144 m, 1.2192 - 1.5240 m, and 2.1336 - 2.4384 m. These data did show variation of moisture content with depth throughout the containment area.

62. Soil moisture content data were collected during the months of August, November, December, February, and March at the locations shown in Figure 7. The August data were used to determine the pre-test in situ moisture content at the various locations. Soil moisture content data collected during the months of November and December are of little value as a measure of electro-osmotic dewatering, since there were few days during the period in which there was an established continuous voltage gradient. Moisture content data collected in February and March also showed no appreciable reduction and, in some cases, even an increase over the moisture content, as determined in August 1976. A typical plot of moisture content vs. depth for each electro-osmotic section and two control sections where there was no electro-osmosis is shown in Figure 12; all moisture content data are shown in Table 7. Although between 3.78 and 151.4 ℓ of water were removed daily from the sumps during February and March, moisture contents did not change to any great extent.

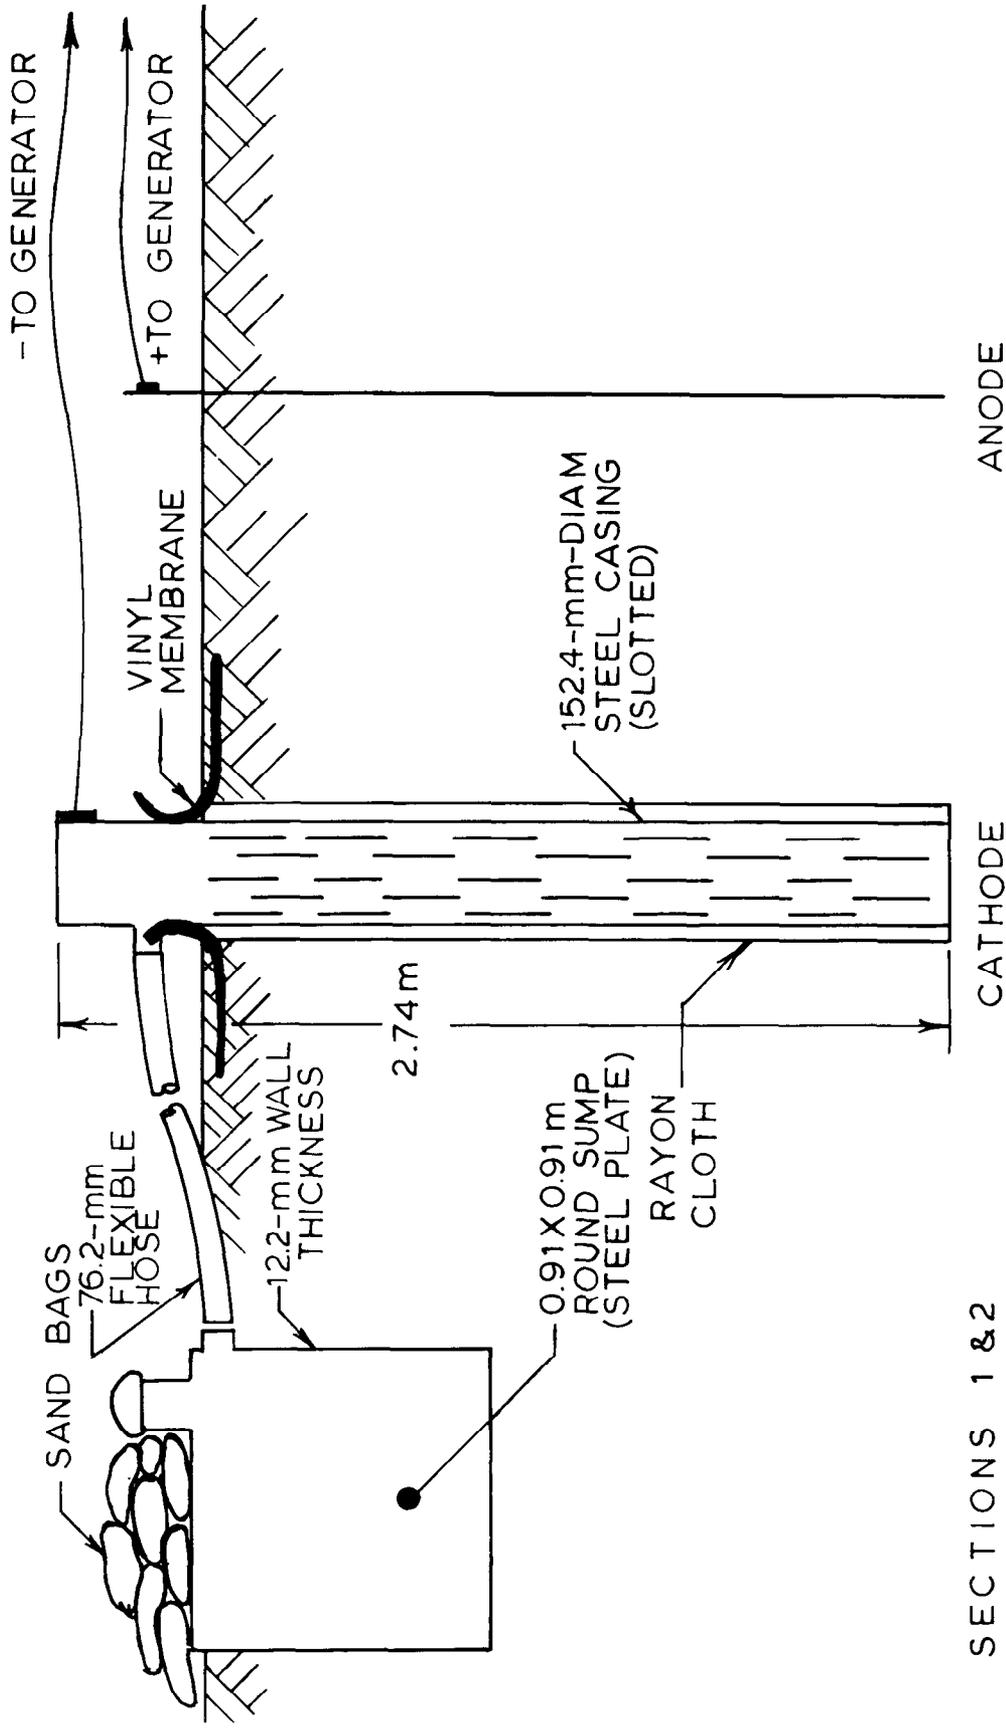
44. Details of the anodes and cathodes are shown in Figures 8 and 9. The details on the sumps for each section are also shown in Figures 8 and 9. Cathodes used for Sections 1 and 2, shown in Figure

SECTIONS 1 & 2
 NOT TO SCALE

Figure 8. Details of electrodes and sump, sections 1 and 2

45. Anodes used in Sections 1 and 2 were initially 50.8-mm-diam hollow steel pipes with 6.3-mm wall thickness, but, during the course of experimentation, these pipes were replaced by 50.8-mm solid steel rods and later by 50.8-mm-diam carbon rods, and finally by railroad rail. Anodes with increasing mass were used during the course of testing because corrosion causes a significant reduction of the anodes and a severing of electrical connection in relatively short periods of time. The steel pipes, both hollow and solid, lasted only 5 to 6 days, the carbon rods 20 days, and the railroad rail 26 days.

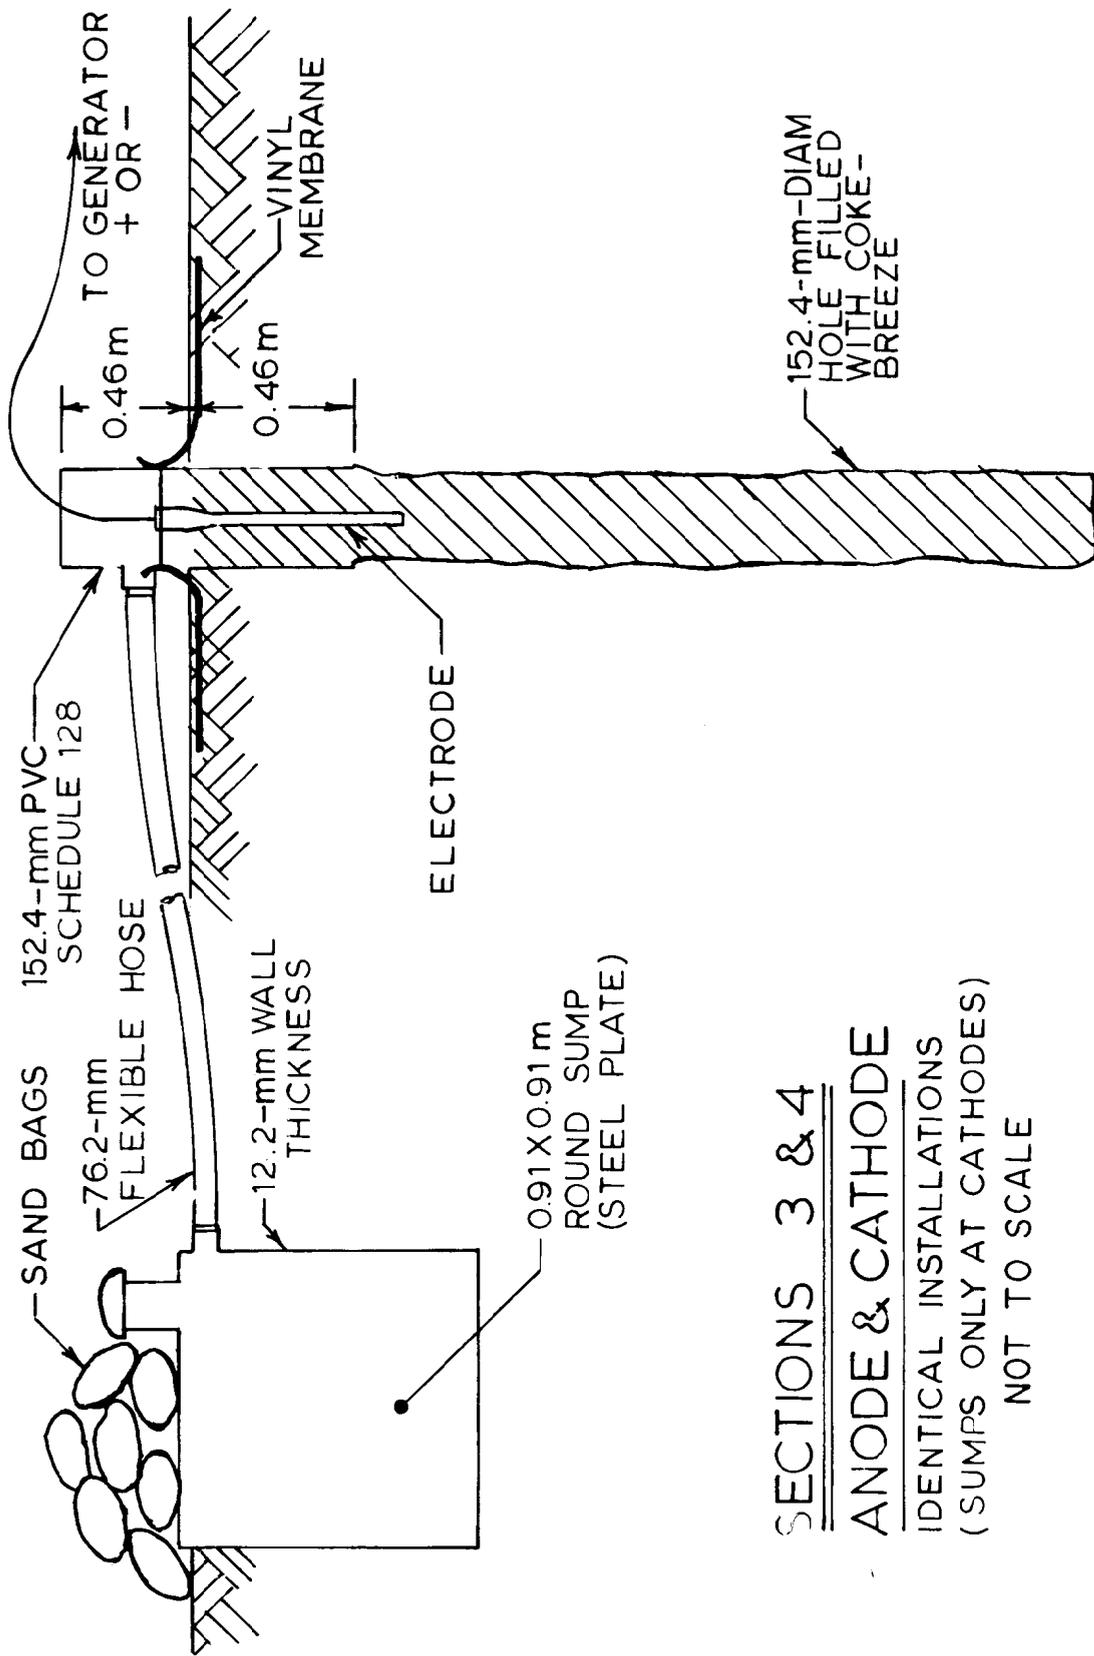
SECTIONS 3 & 4
ANODE & CATHODE
 IDENTICAL INSTALLATIONS
 (SUMPS ONLY AT CATHODES)
 NOT TO SCALE

Figure 9. Details of electrodes and sump, sections 3 and 4

Figures 8 and 9. Water flowing from cathodes to the sumps was removed periodically by pumping.

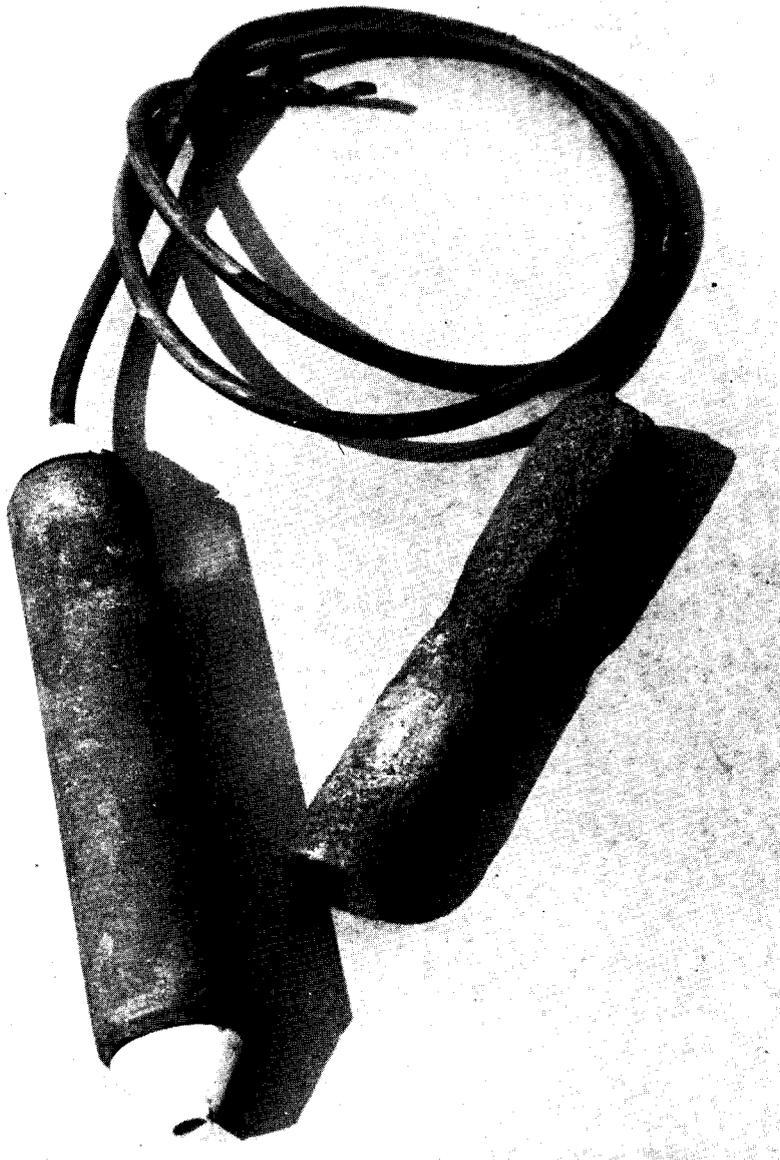
Figure 10. New 10.0-kg Duriron electrode and one that has lost one half its weight after use for 25 days at a voltage gradient of 0.01 V/mm

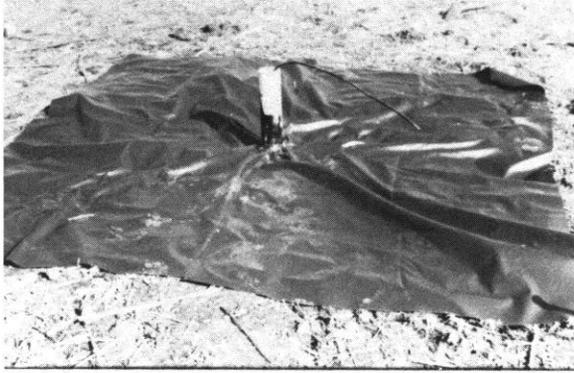
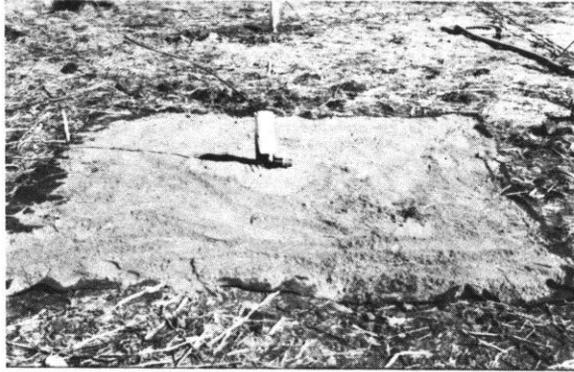
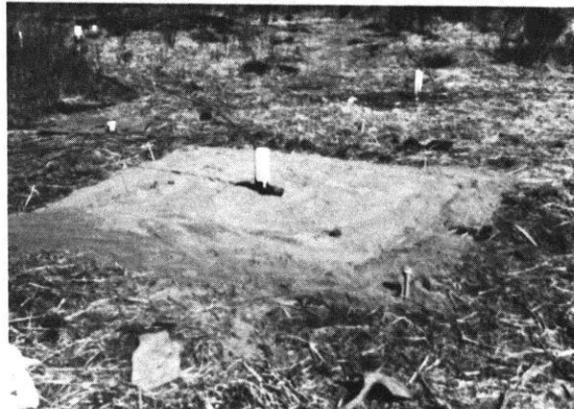
square m vinyl membrane was installed around each cathode. The installation consisted of placing the membrane around the cathode, in each section, and covering it with a 101.6- to 152.4-mm layer of sand. A typical vinyl membrane, shown in Figure 11, was successful in preventing migration of water to the surface around the cathodes. Before the system was restarted on 12 November, the carbon rods in Sections 1 and 2 were wrapped with plastic tape 228.6 mm above and below where the crust and the underlying material were in contact. From 12 November through 14 December, Sections 3 and 4 ran continuously; however, Sections 1 and 2 were not in operation from 20 through 30 November due to a blown fuse in each section. The fuses were replaced, and from 1 December through 6 December, both sections continued to run. The carbon rods lost electrical connection on 6 December and were replaced with railroad rail in Section 2; this section continued to function until 14 December when the system was shut off in order to replace the 208-l metal drum sumps. This was necessary because the thin metal drum had badly corroded and would no longer hold water. In the period from 14 December through 22 December, heavy duty sumps (see Figures 8 and 9) were installed in each section. These sumps proved to be effective and were operational when the test was stopped in March 1977. From 22 December through 1 January 1977, the total system was off for most of the time due to blown fuses, holidays, and generator servicing. On 17 January, the carbon rod anode in Section 1 was replaced with a railroad rail. From 1 January through 31 January, all sections were

Figure 11. A typical vinyl membrane installed at cathode in all sections

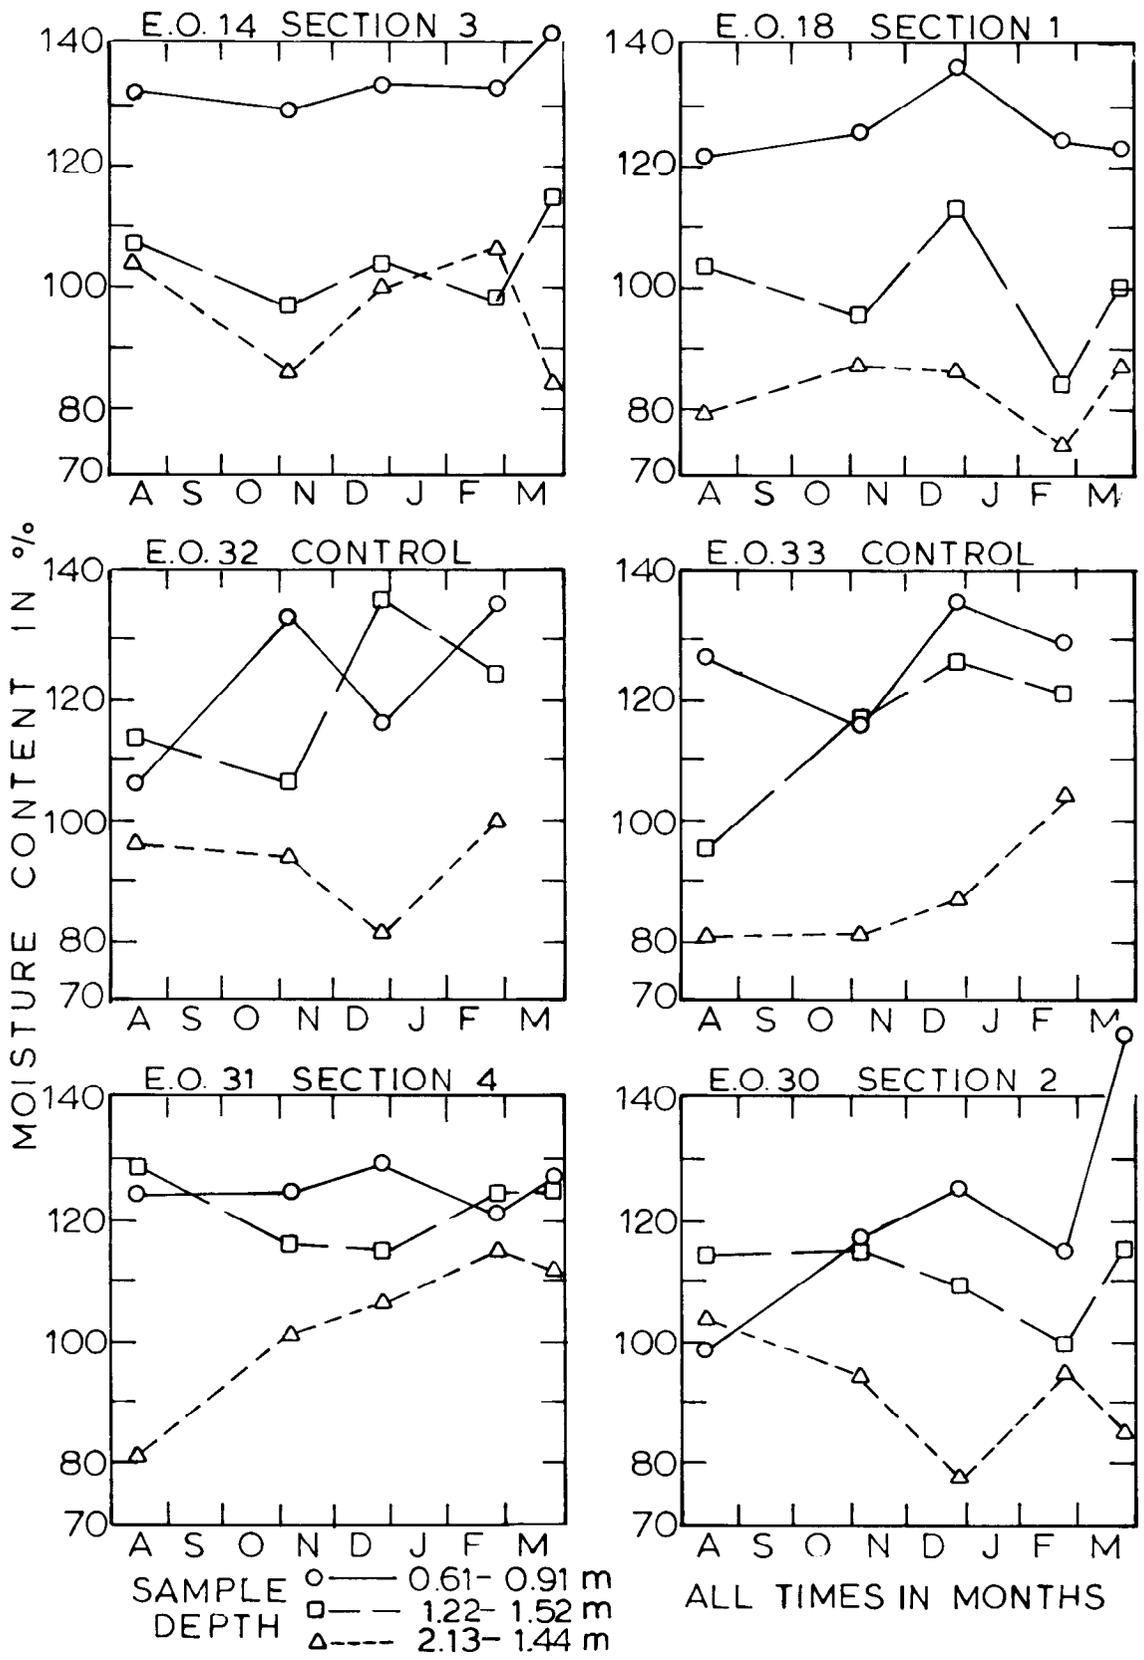
Figure 12. Typical moisture content vs. time at various depths, all sections and two control locations

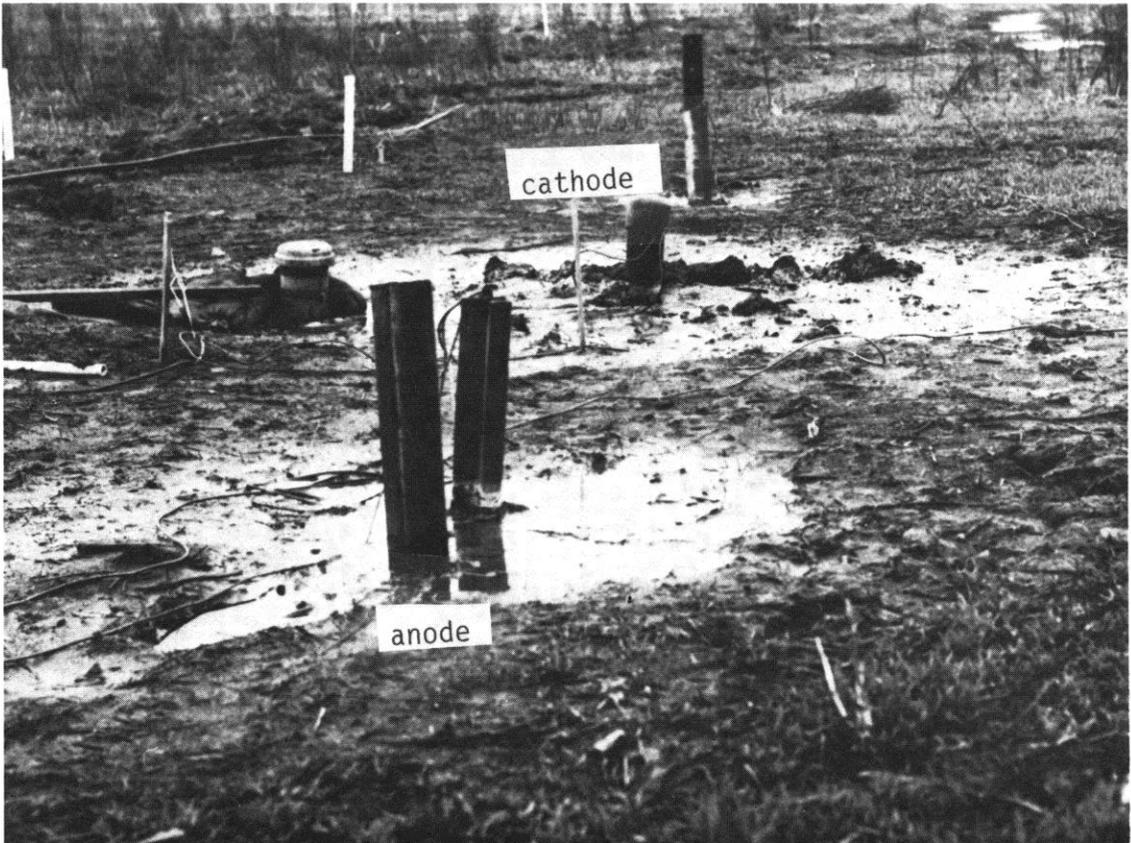
63. During January 1977, it rained for a total of 14 days in Mobile; accumulated rainfall was 140.7 mm. In February, 47.24 mm fell in a period of 6 days, and, during the first 2 weeks of March, 73.91 mm fell in a total of 7 days. This rain caused the anodes and cathodes to often be submerged in water; this is shown in Figures 13 and 14.

Figure 13. Standing water at anode, Section 2

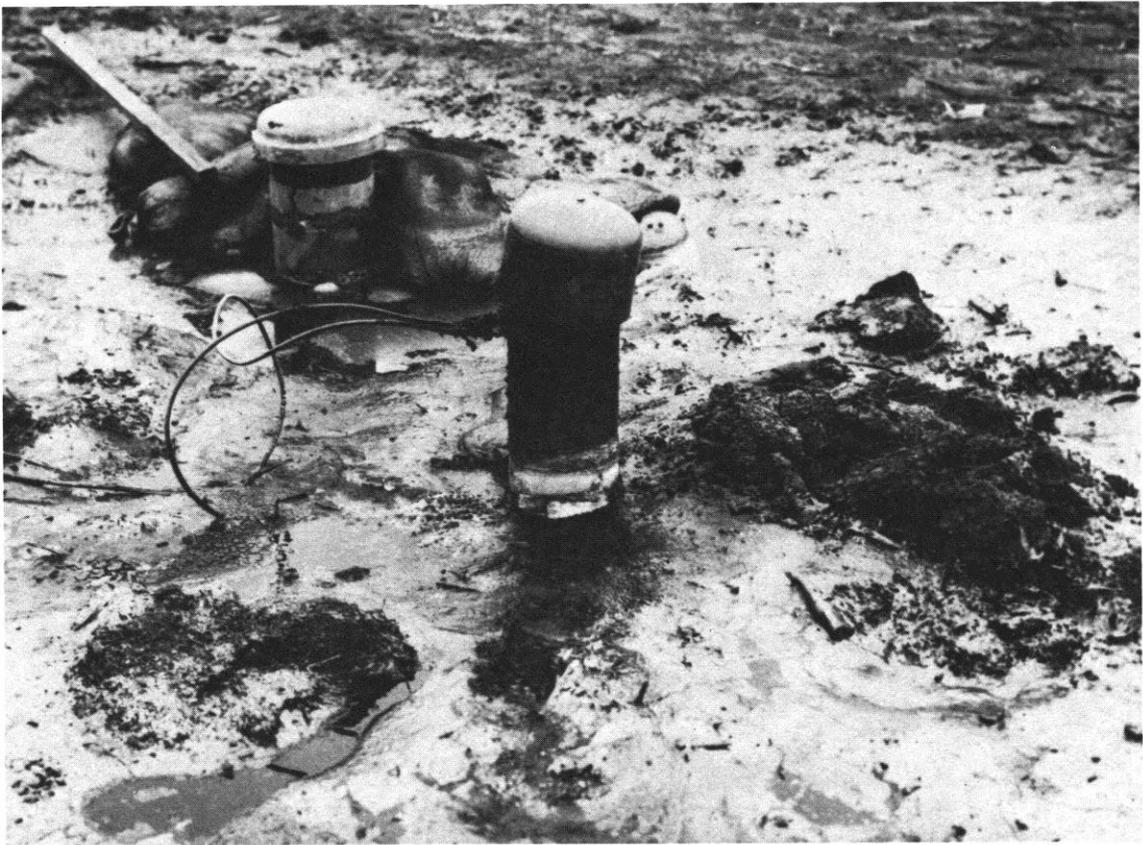
Figure 14. Standing water at cathode, Section 1

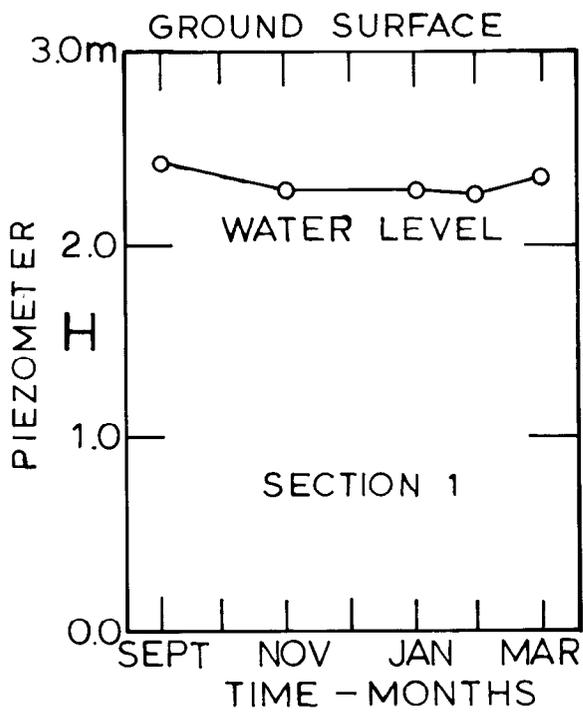
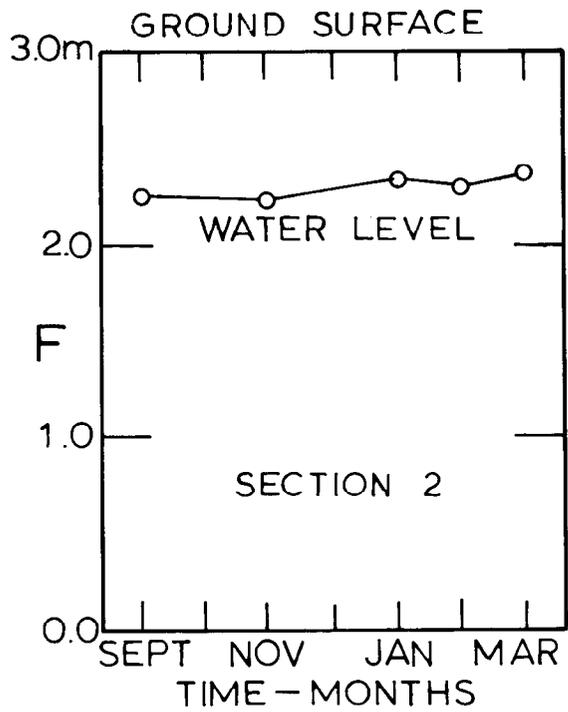
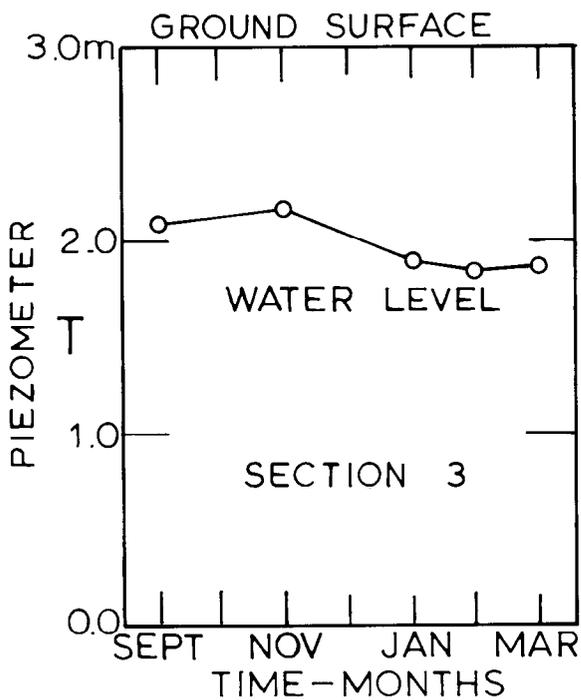
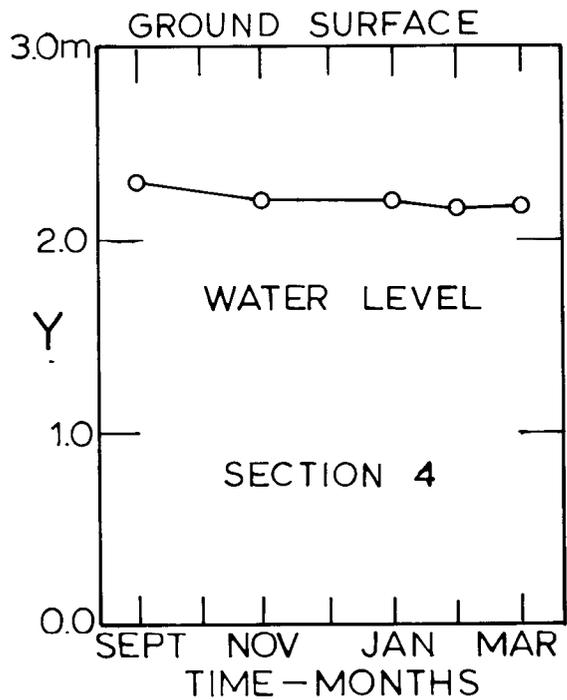
and every day from 29 January through 14 March 1977. These data did not show any drying front in any of the sections and, in fact, had very little variation during the entire eight-month period. A typical plot of the data for each section is shown in Figure 15.

Figure 15. Typical plot of piezometer data vs. time (all sections)
