DREDGED MATERIAL RESEARCH PROGRAM

MISCELLANEOUS PAPER D-77-2

FIELD STUDY TO DETERMINE THE FEASIBILITY OF ELECTRO-OSMOTIC DEWATERING OF DREDGED MATERIAL

November 1977

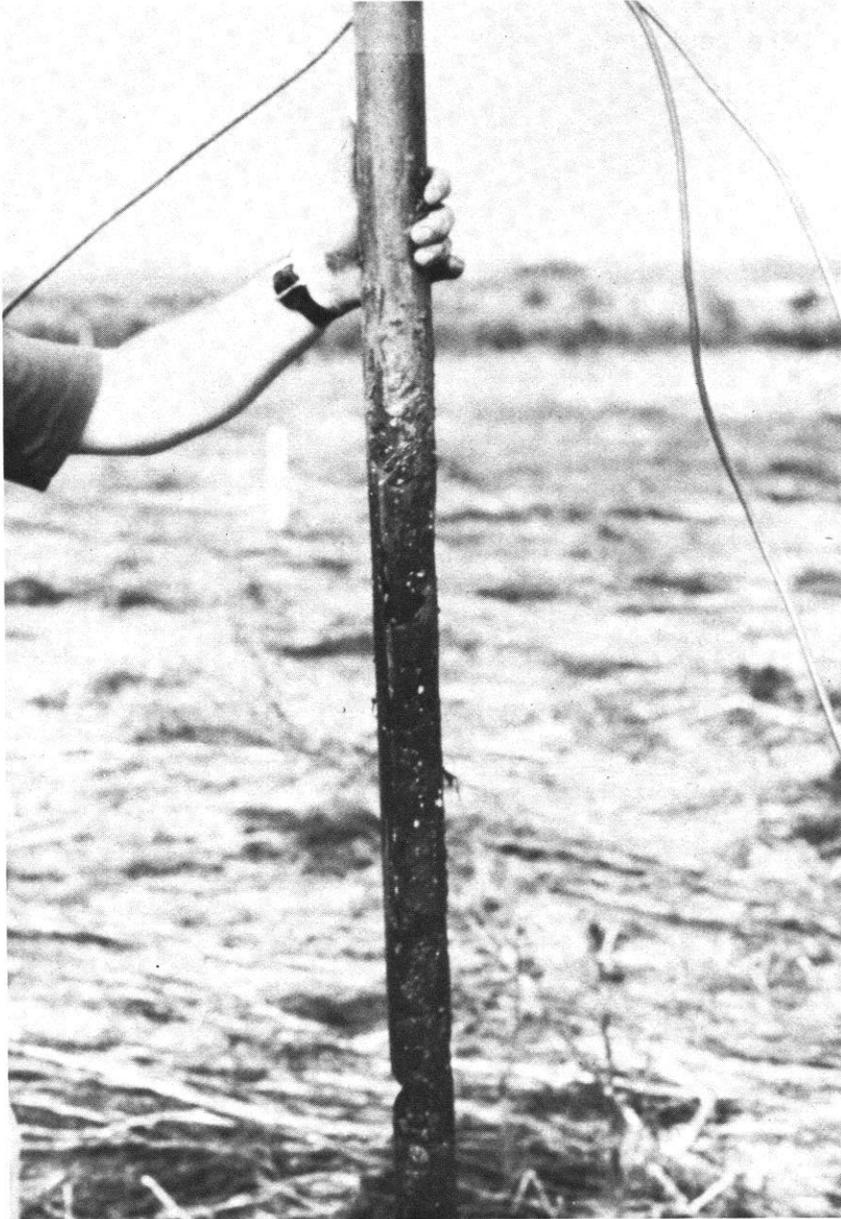
73. Steel corrosion occurred very rapidly at the Polecat Bay site. The 50.8-mm hollow steel pipe, used initially, failed by corroding to such a degree that the electrical circuit was broken in about five days. The steel pipe failures are shown in Figures 16 and

Figure 16. 50.8-mm hollow steel pipe anode in Section 2 failed in 5 days at a voltage gradient of 0.008 V/mm

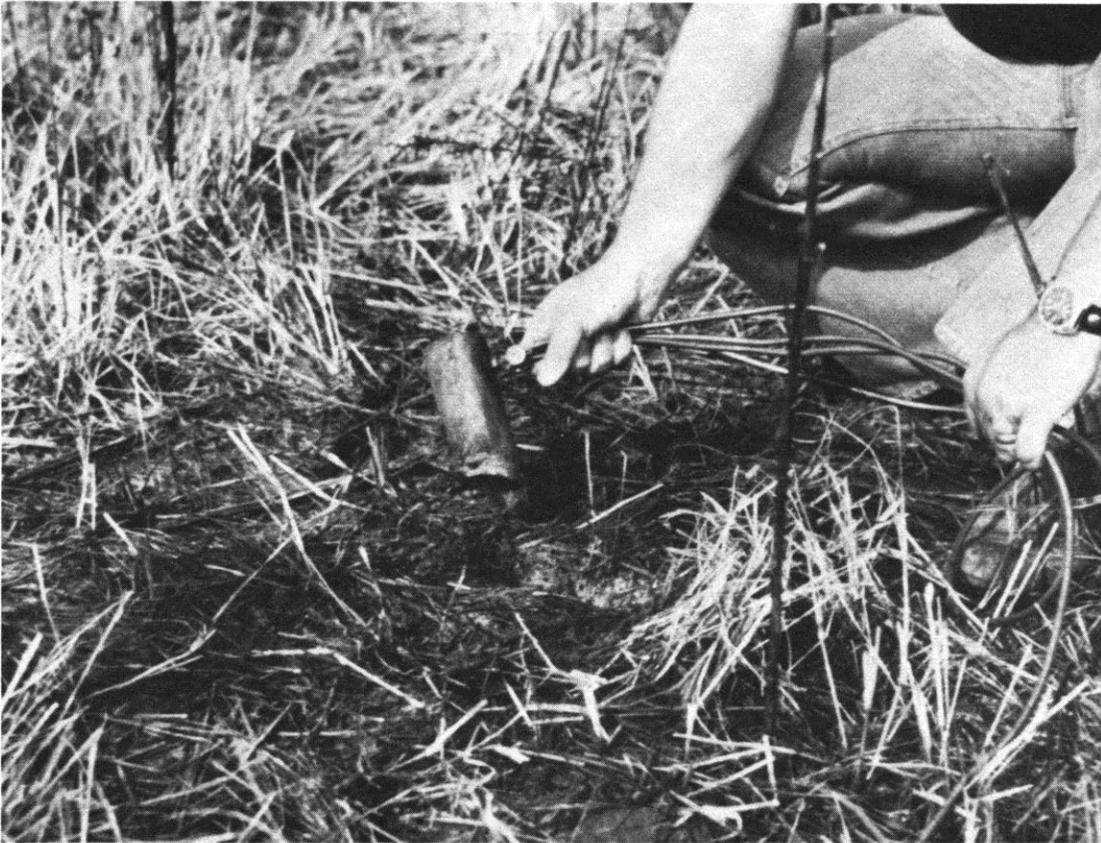
Figure 17. Closeup view of 50.8-mm hollow steel pipe anode in Section 2 that failed in 5 days at a voltage gradient of 0.008 V/mm

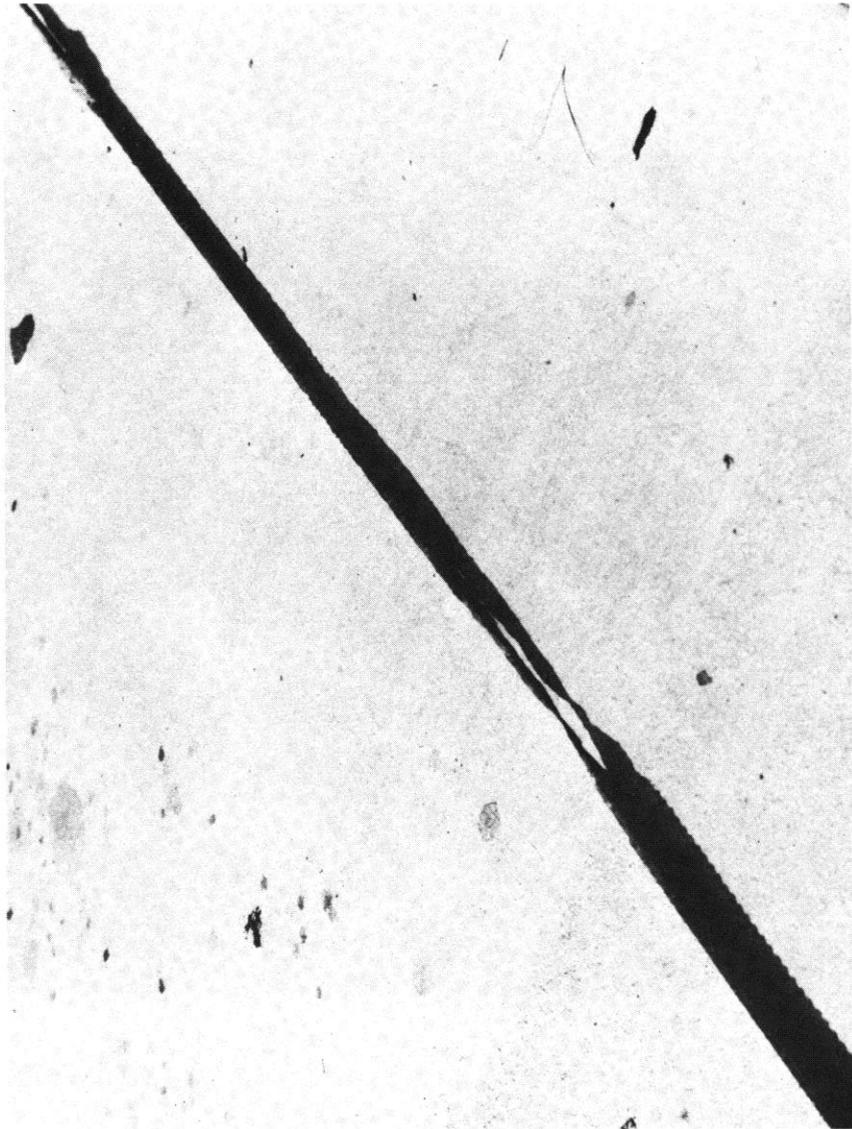
17. The 50.8-mm solid steel anode, shown in Figure 18, failed in a little over 6 days. This figure shows fairly uniform corrosion over most of the bars 2.74-m length, with excessive corrosion at the tip of the bar and localized corrosion just below the ground surface. Carbon bars, shown in Figure 19, failed in 20 days and were very difficult to install. The railroad rail, shown in Figure 20, failed in about 26 days. These rails could not be pulled out for inspection; however, failure generally occurred near the ground surface.

Figure 18. 50.8-mm solid steel rod anode in Section 2 failed in 6 days at a voltage gradient 0.008 V/mm

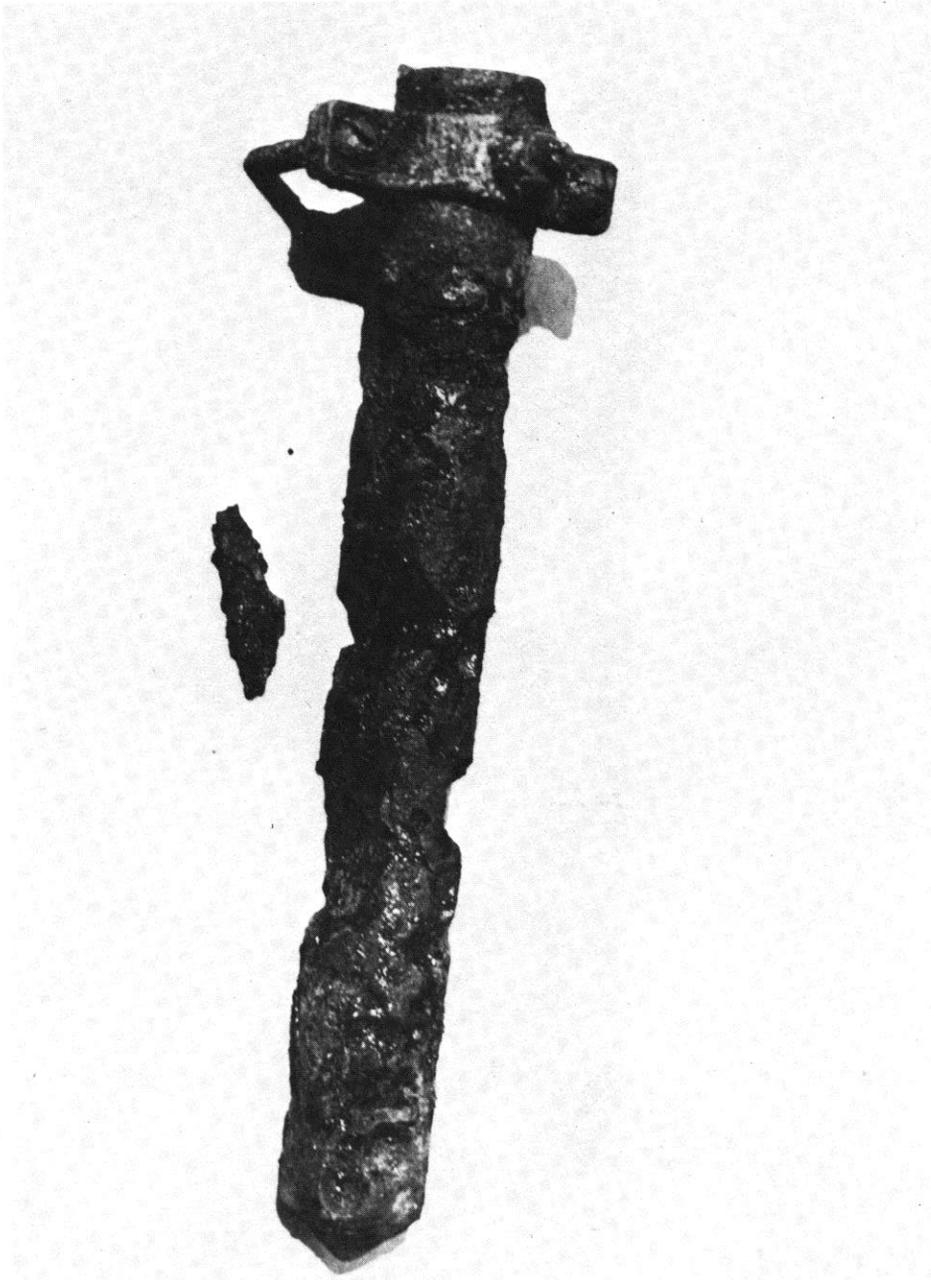
Figure 19. 50.8-mm solid carbon bar anode in Section 2 failed in 20 days at a voltage gradient of 0.008 V/mm

45. Anodes used in Sections 1 and 2 were initially 50.8-mm-diam hollow steel pipes with 6.3-mm wall thickness, but, during the course of experimentation, these pipes were replaced by 50.8-mm solid steel rods and later by 50.8-mm-diam carbon rods, and finally by railroad rail. Anodes with increasing mass were used during the course of testing because corrosion causes a significant reduction of the anodes and a severing of electrical connection in relatively short periods of time. The steel pipes, both hollow and solid, lasted only 5 to 6 days, the carbon rods 20 days, and the railroad rail 26 days.

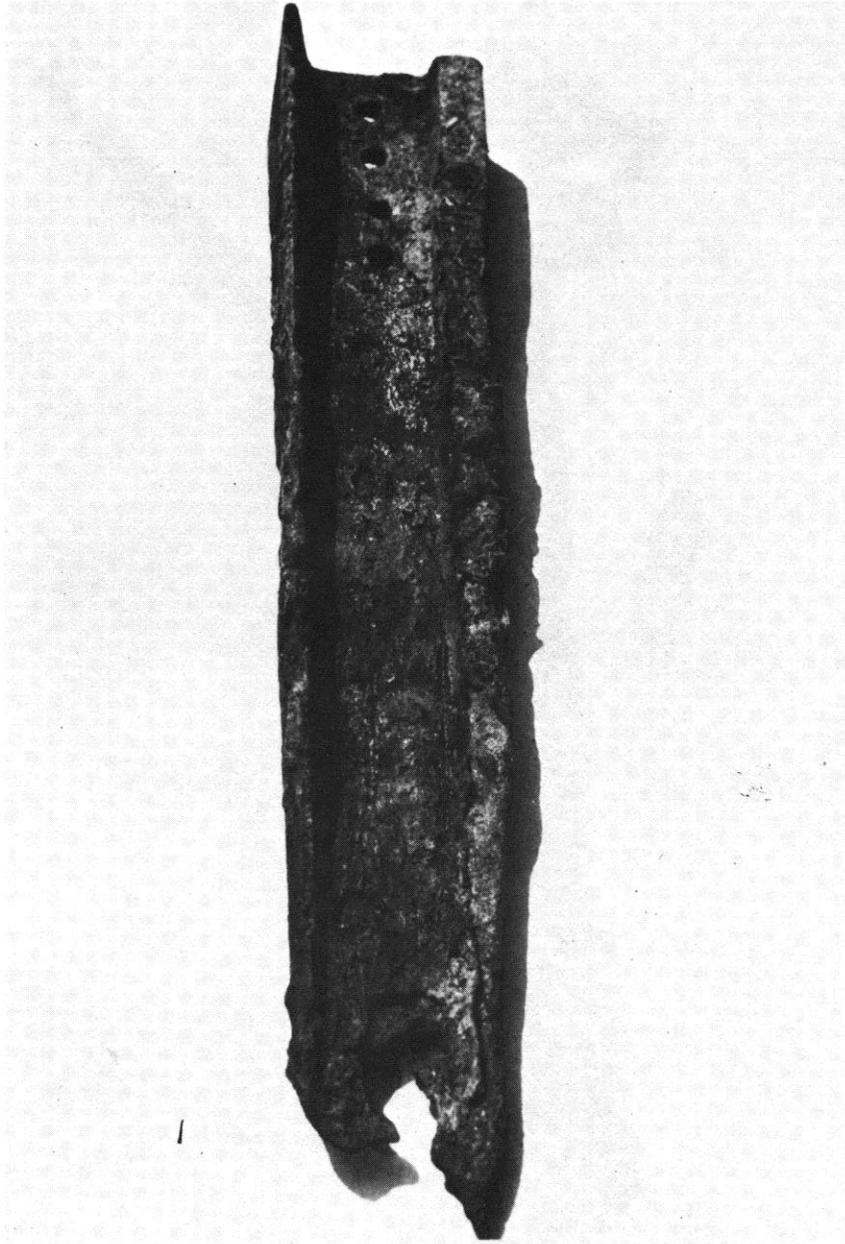
Figure 20. Railroad rail anode in Section 2 failed in 26 days at a voltage gradient of 0.008 V/mm

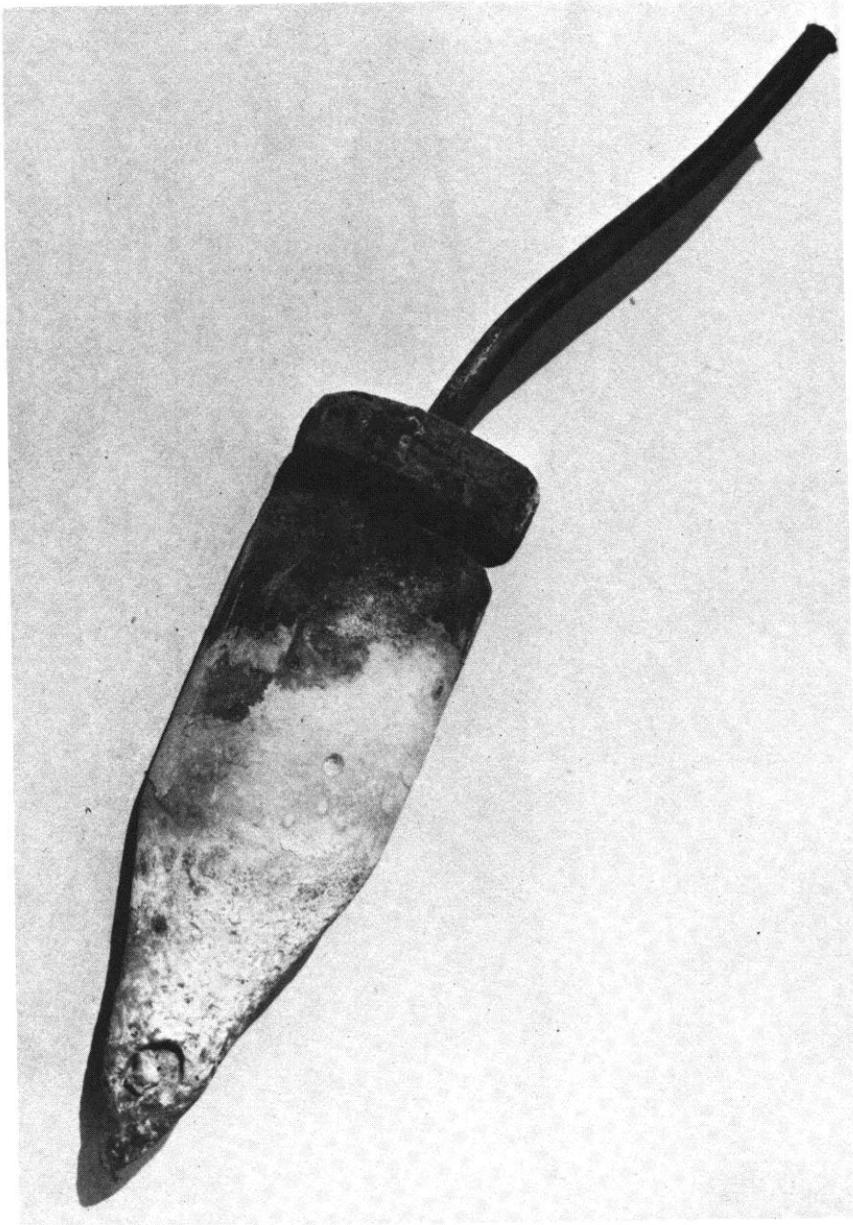
74. In Sections 3 and 4, the 10.9-kg Duriron electrodes failed by loss of electrical connection in about 53 days. Since it would have taken 3 weeks to obtain new ones from the manufacturer, a hardened aluminum bronze bar, approximately 50.8 mm diam, 1 m long, was used for the electrical connection. These bars lasted only 16 days, but were locally available, thereby allowing the test to continue. Figures 21 and 22 show deterioration of the Duriron and hardened aluminum bronze metal use as connectors in the coke-breeze sections.

Figure 21. 10.9-kg Duriron electrode anode in Section 4 failed in 53 days at a voltage gradient of 0.008 V/mm

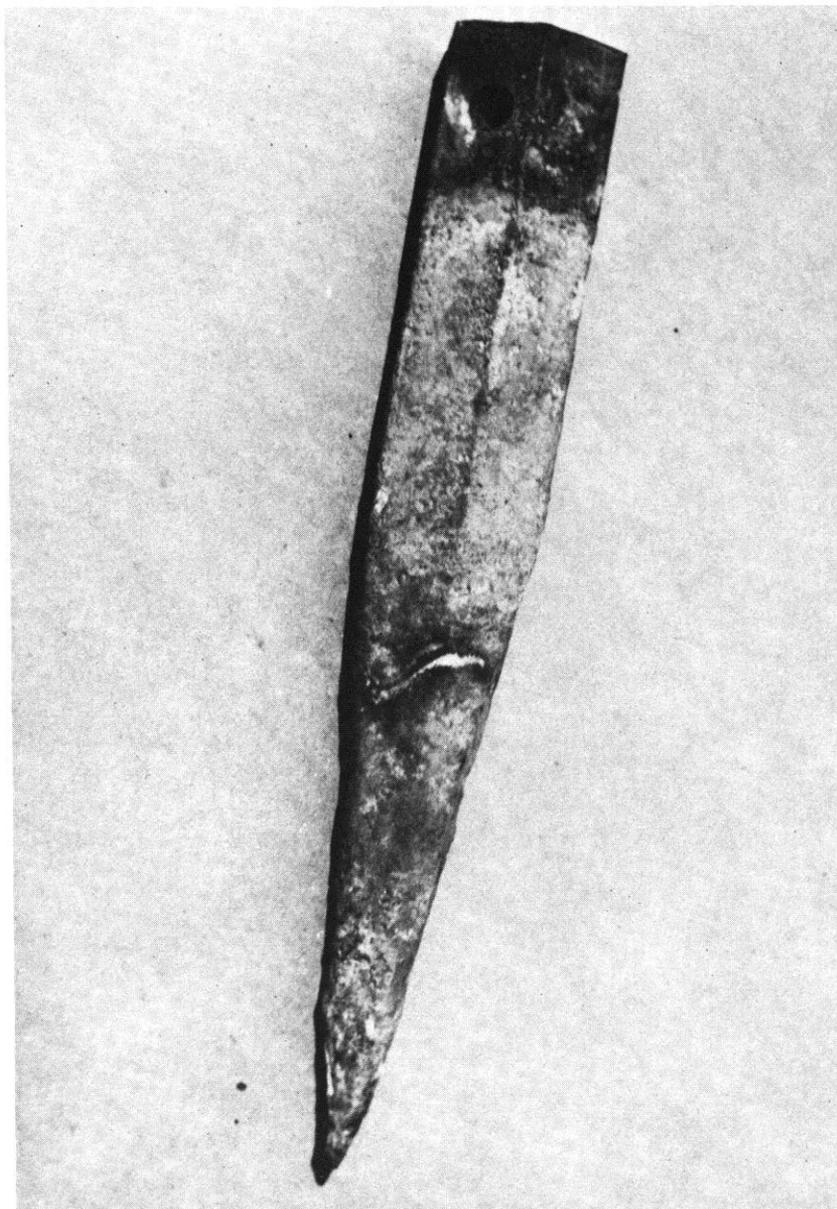
Figure 22. 50.8-mm hardened aluminum bronze anode in Section 4 failed in 16 days at a voltage gradient of 0.008 V/mm
