# DREDGED MATERIAL RESEARCH PROGRAM

MISCELLANEOUS PAPER D-78-3

## PERIMETER DIKE RAISING WITH DEWATERED FINE-GRAINED DREDGED MATERIAL AT UPPER POLECAT BAY DISPOSAL AREA MOBILE, ALABAMA

August 1978

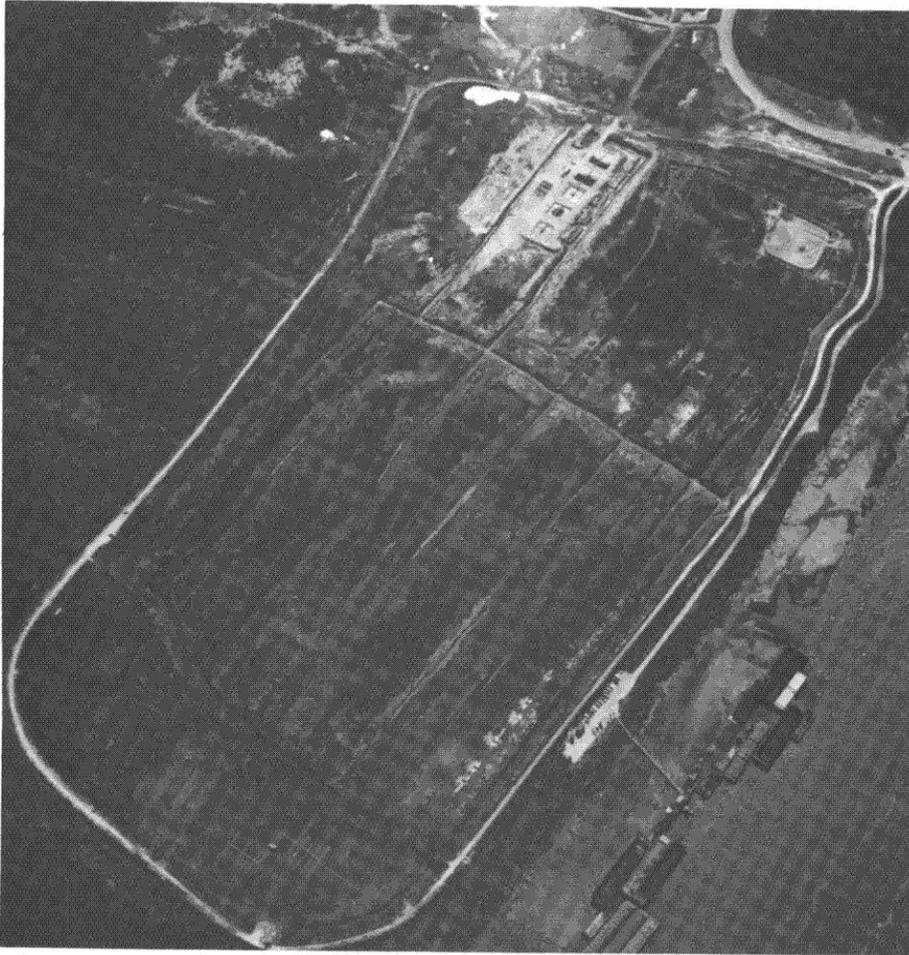
Figure 2. Aerial view of Upper Polecat Bay Disposal Area prior to initiation of dike-raising activities. Note the surface drainage network produced by DMRP DOP dewatering field demonstrations. North toward the lower left corner of the photograph

69. As shown in Figures 2 and 5, the southeast portion of the disposal area, where the dredge inlet pipe was normally placed, had been covered with a large sand mound. A DOP underdrainage study described elsewhere<sup>5</sup> was still in progress in this area. Construction of underdrainage test pits had raised elevations in this portion of the site to approximately El. 21 to 23 MSL. The perimeter dike was relocated around this ongoing DOP experiment, the perimeter of the experiment raised to El. 24 MSL, and a short dike segment constructed from the DOP experiment area to the original east dike, located as shown in Figure 5. This dike segment, shown in Figure 22, was constructed up to El. 25 MSL from existing ground elevations in the vicinity of El. 14 to 18 MSL in one lift using essentially uncompacted, coarse-grained material. A small amount of raising around the perimeter of the DOP underdrainage work units was accomplished by the small wide-track dozer. Construction operations in this part of the disposal area proceeded smoothly. As coarse-grained material was

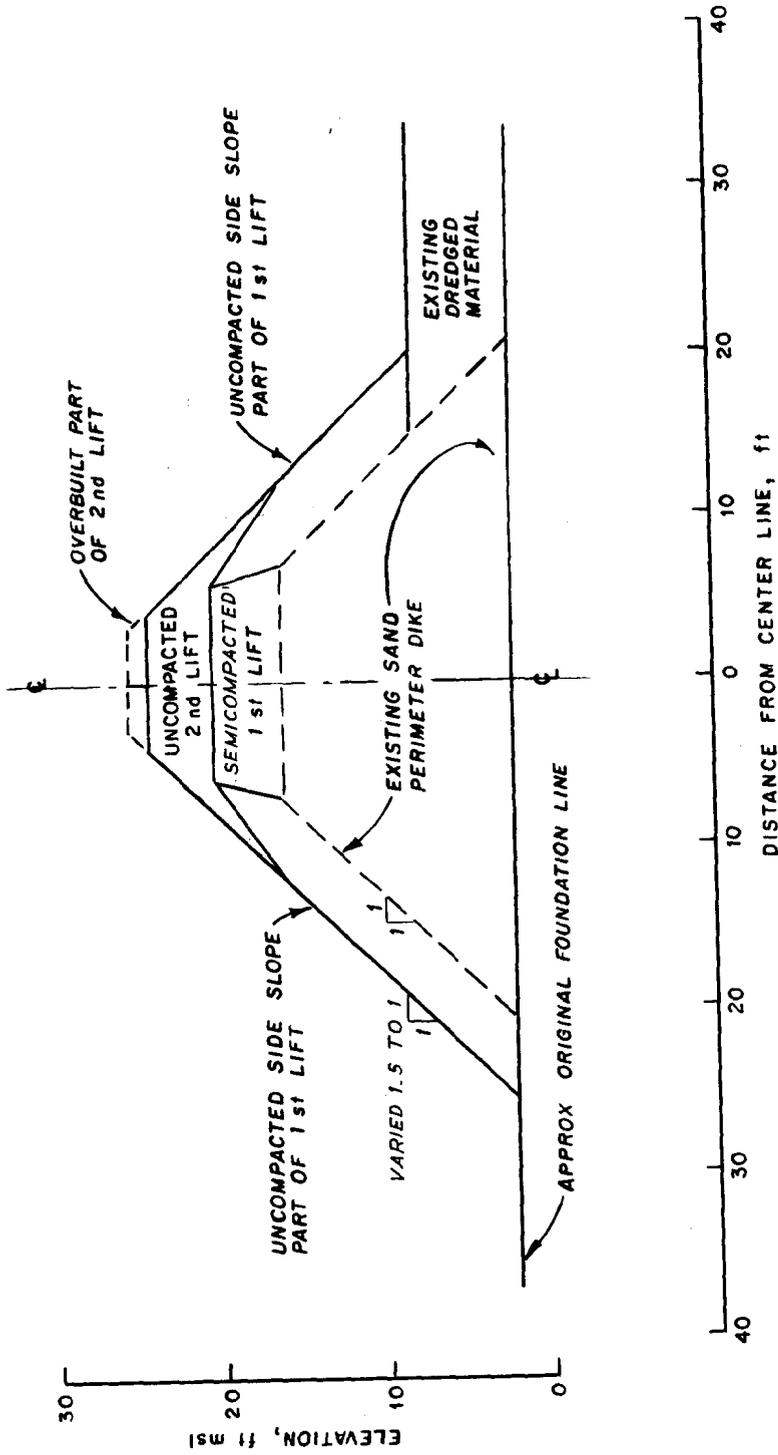
Figure 3. Typical cross section of raised perimeter dike showing semicompacked first lift and uncompacted second lift of fine-grained dredged material

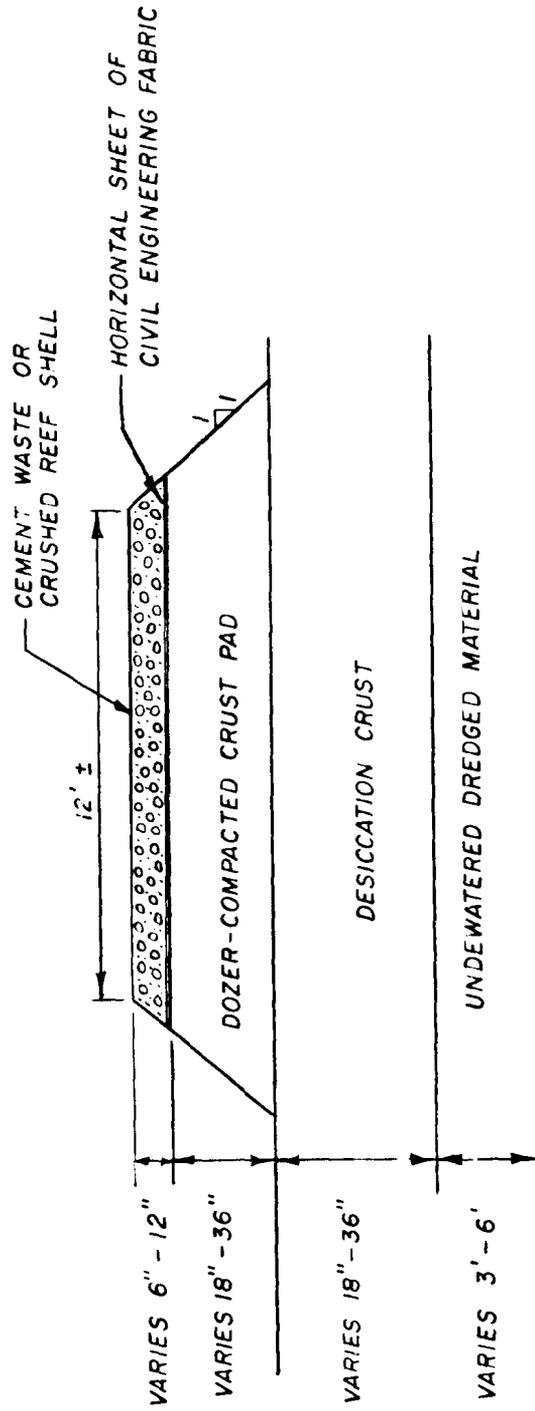
Figure 4. Typical cross section of haul roads constructed on dewatered dredged material crust

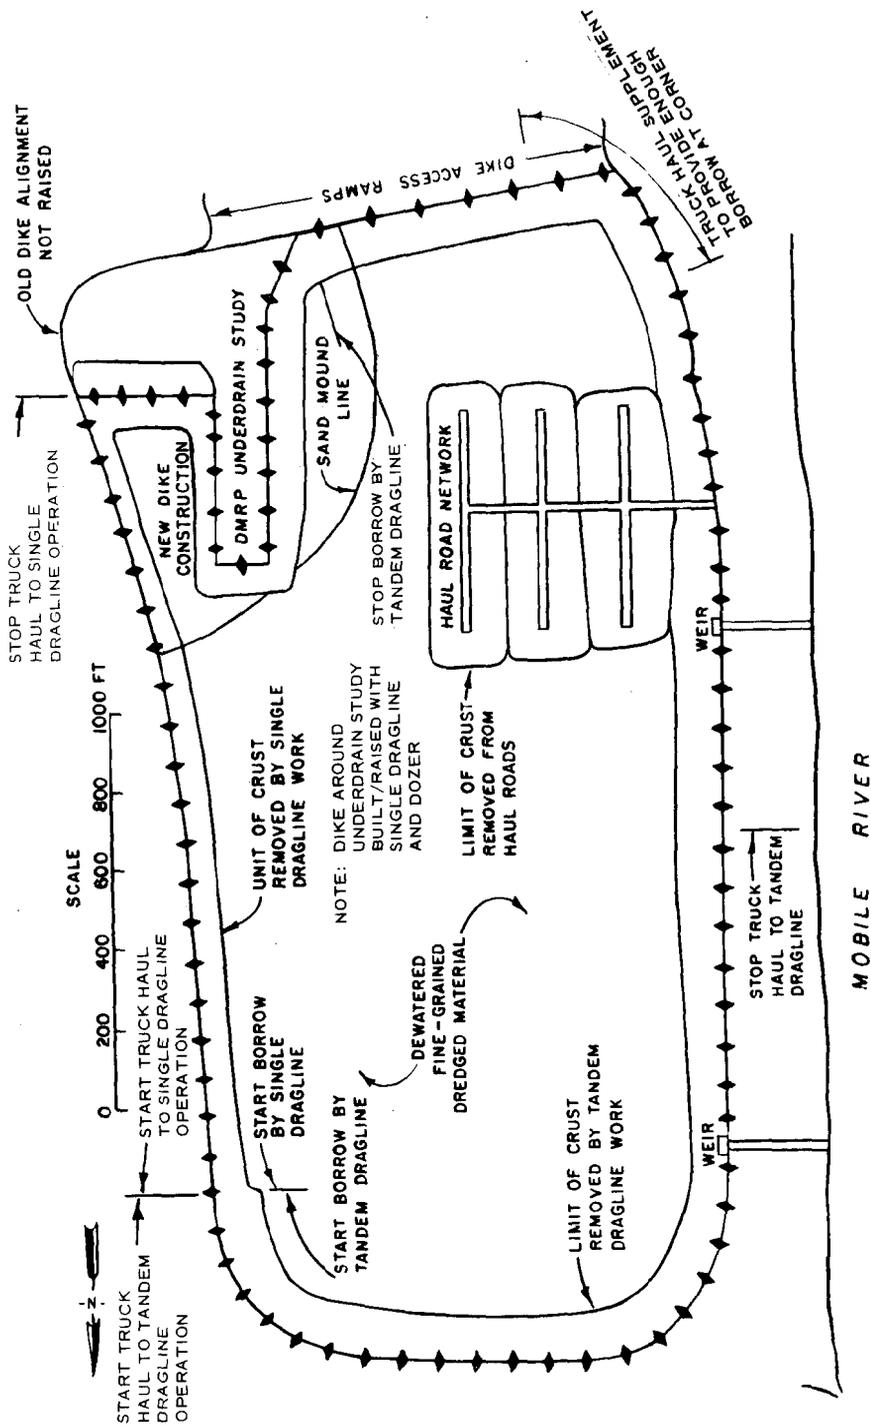
Figure 5. Plan of Upper Polecat Bay Disposal Area showing different procedures used to obtain dewatered fine-grained dredged material for use in perimeter dike raising

33. The overall proposed material borrow construction plan is shown in Figure 5. Locations along the dike alignment where various construction schemes were evaluated are noted. Calculations indicated that a main haul road with three spur haul roads was necessary to provide the necessary 40,000 lcy of material, assuming the haul roads themselves would also be removed (as the last operational item) and used as borrow. The perimeter dike in the southeast corner of the disposal area was rebuilt at a new location, as shown in Figure 5, to isolate DOP-dewatering experiments still in progress at the time of dike raising. This portion of the dike, across the sand mound deposited from previous disposal operations, was constructed essentially of coarse-grained material.

40. Following the operational scheme shown in Figure 5, tandem dragline borrow removal operations were initiated in the northeast corner of the disposal area, progressing west along the north dike and thence south along the west dike, coincident with the start of site interior haul road construction. Good weather was encountered, and this initial phase of the borrow removal operation proceeded smoothly. Expected production capacity of 40 lcy/hr was obtained and/or exceeded for the small dragline placed inside the disposal area, and the large dragline on the perimeter dike was able to rehandle this material without delay while removing crust from immediately inside the disposal site perimeter. This part of the operation is shown in Figures 6 and 7. As may be seen in the figures, essentially all crust was removed within a swath three dragline boom widths (approximately 150 ft) from the inside toe of the perimeter dike. A drainage ditch was maintained in the remaining dredged

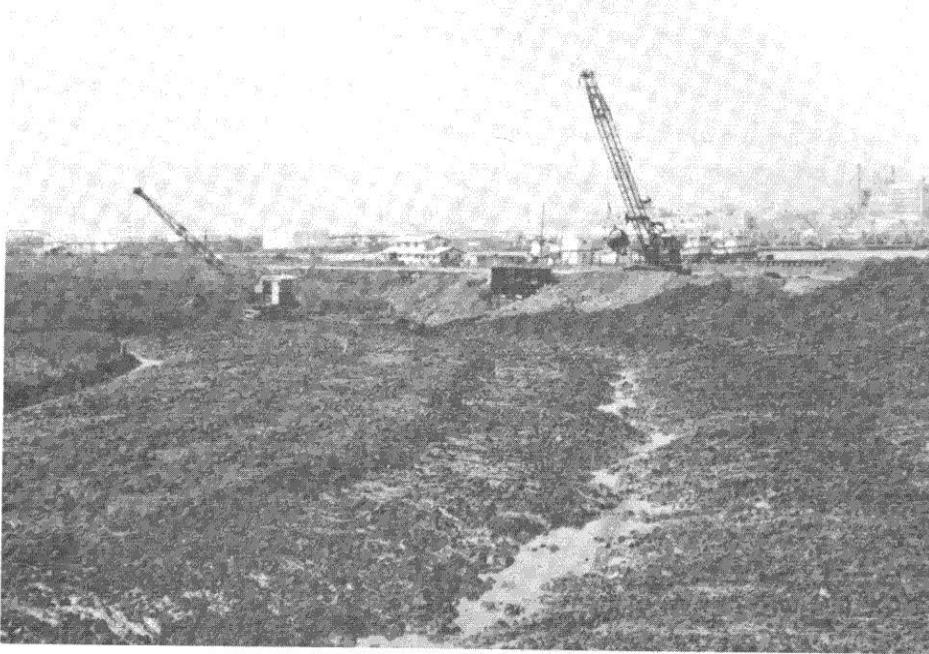
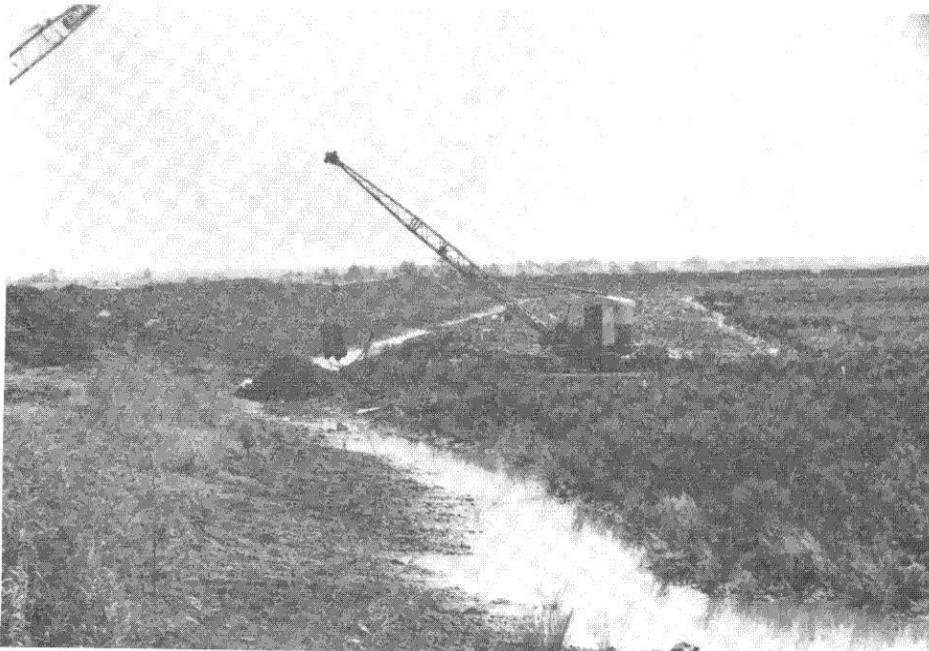
- a. Tandem dragline operation removing dewatered fine-grained dredged material. Operation has reached the northmost weir location

- b. View of small dragline working on mats inside perimeter dike. Note pile of material placed for large dragline rehandling and drainage ditch maintained after borrow removal

Figure 6. Tandem dragline borrow removal operation

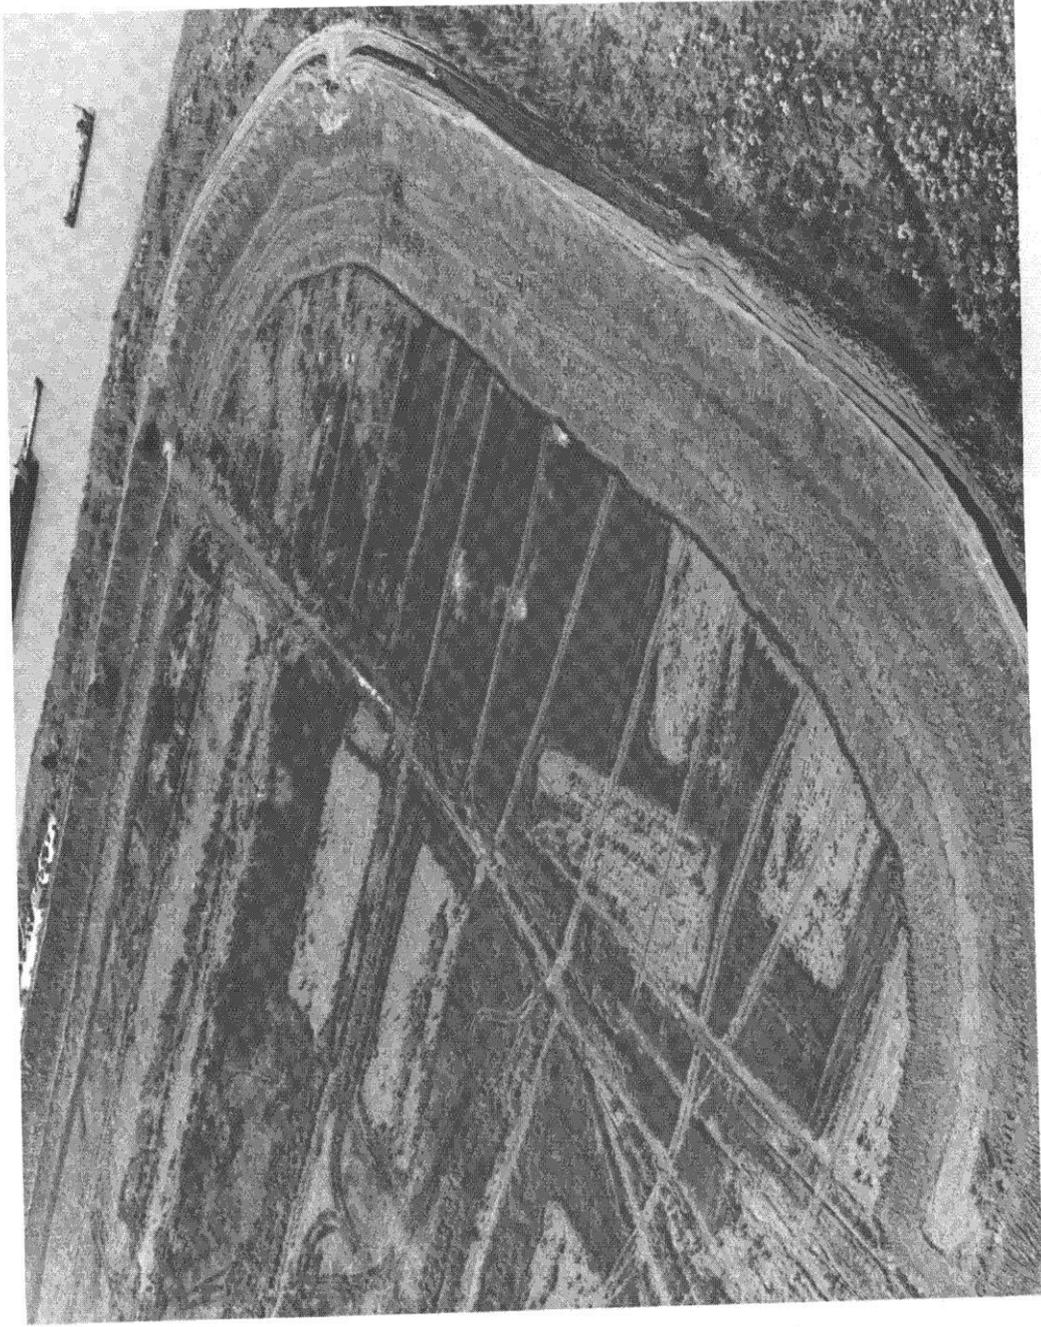
Figure 7. Aerial view of north end of Upper Polecat Bay Disposal Area, looking west southwest from northeast corner. Note strip of dewatered fine-grained dredged material removed around disposal site perimeter

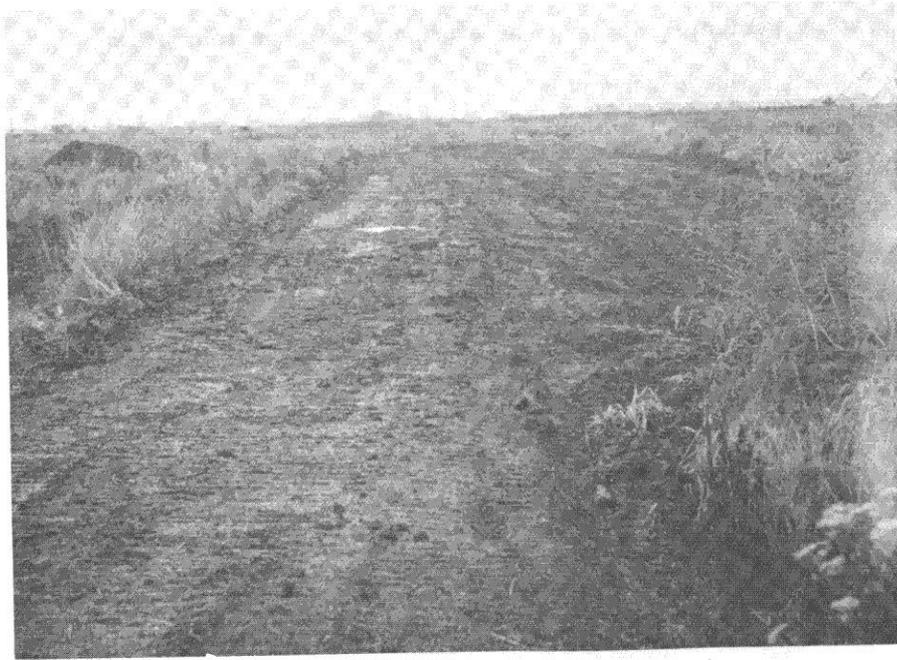
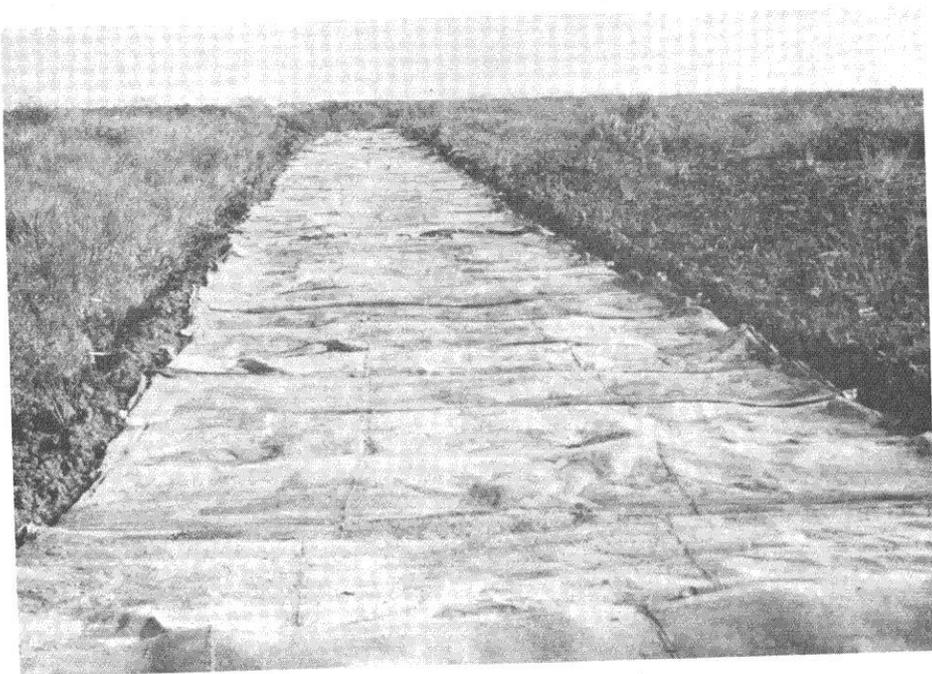
a. Mounded subgrade for interior haul roads was constructed with the small wide-track dozer. Material was bladed from the right of the photograph and semicompacted to form the haul road pad shown in the center of the photograph

b. After the pad was complete, 12-ft-square sheets of filter fabric were laid on the pad and overlapped

Figure 8. Details of interior haul road construction

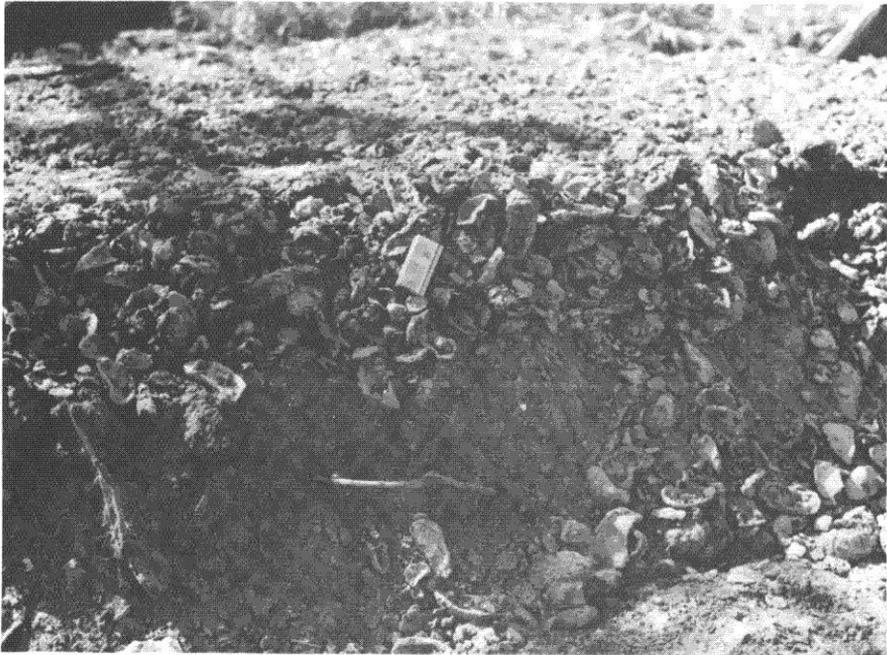
Figure 9. Photograph of completed haul road section showing dredged material surface, semicompacted subgrade mound, and shell surfacing. The fabric was placed at the interface between surfacing and subgrade

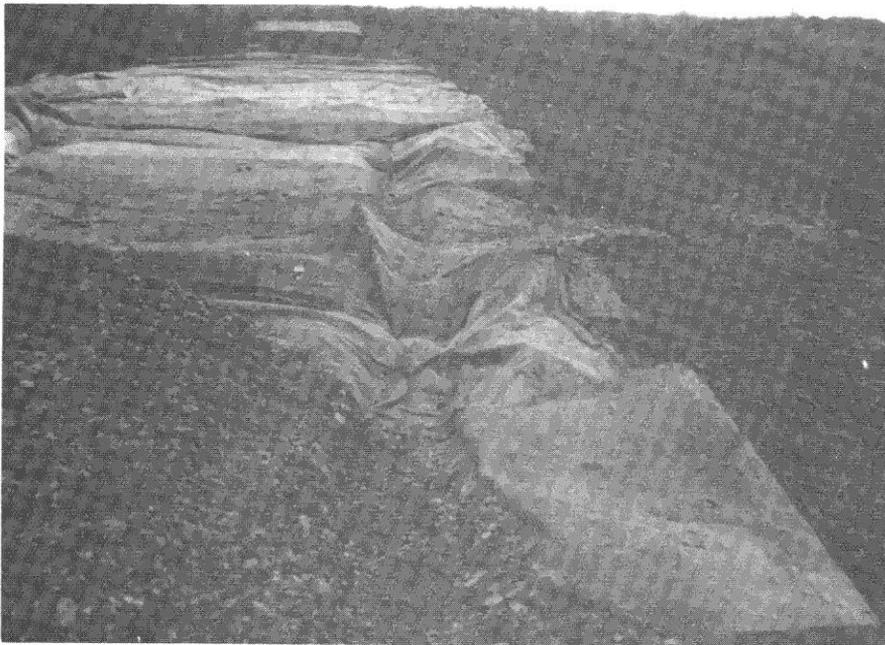
Figure 10. Rutting in the fabric-supported subgrade occurred when trucks backing down the haul road spreading shell continued to back after their load was exhausted. The photograph illustrates the need for fabric cover to obtain desired roadway performance

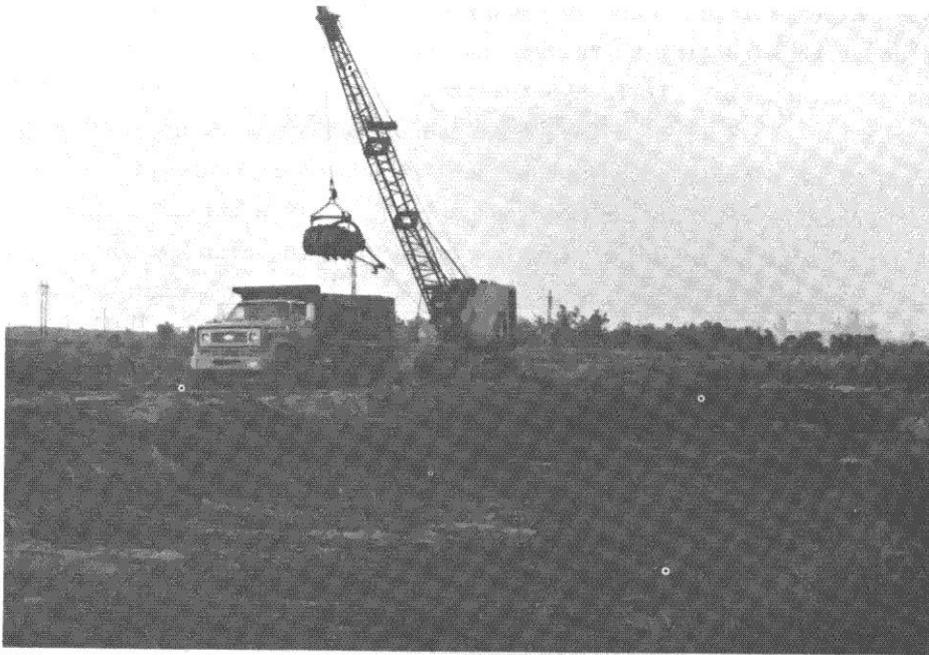
Figure 11. Medium dragline shown loading dump trucks with dewatered fine-grained dredged material in interior borrow area

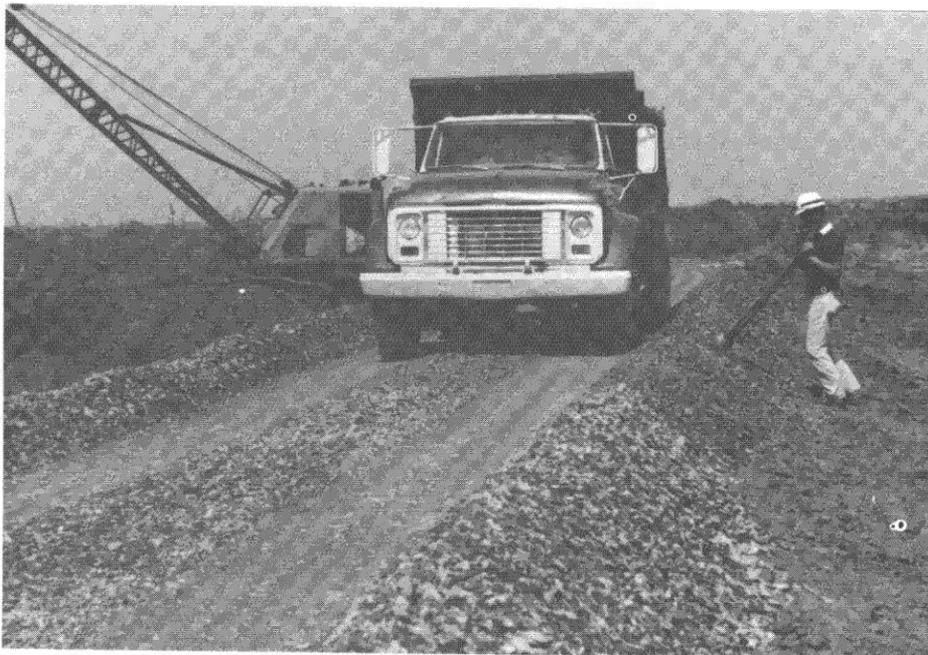
Figure 12. Photograph of spur haul road surface after approximately 300 load repetitions. Note relatively good condition of surface with minimal rutting in wheel paths

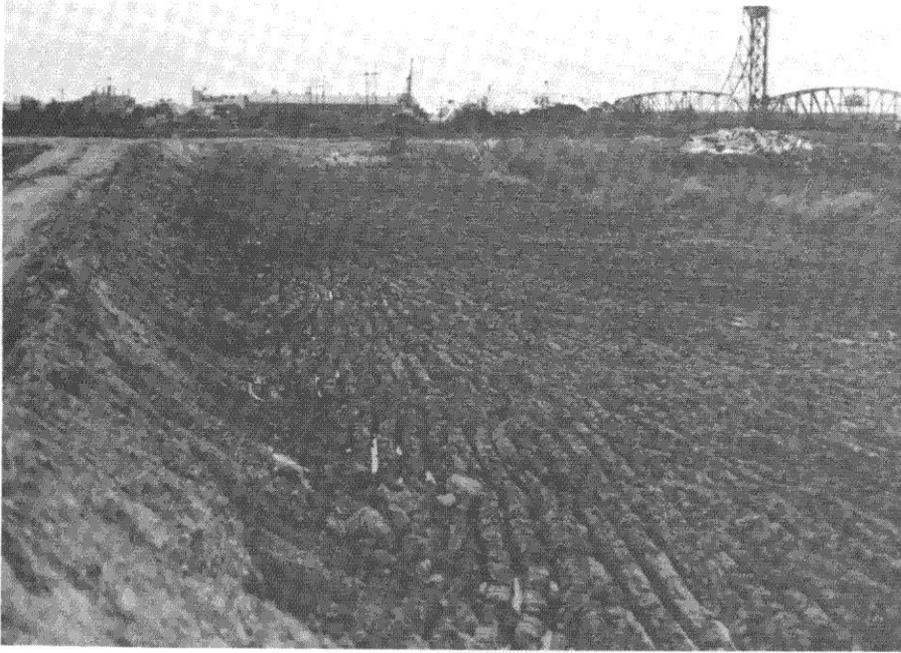
Figure 13. View along edge of spur haul road after dredged material crust had been removed. No evidence of subgrade bulging, foundation bearing failure, or mud waves is seen in the photograph

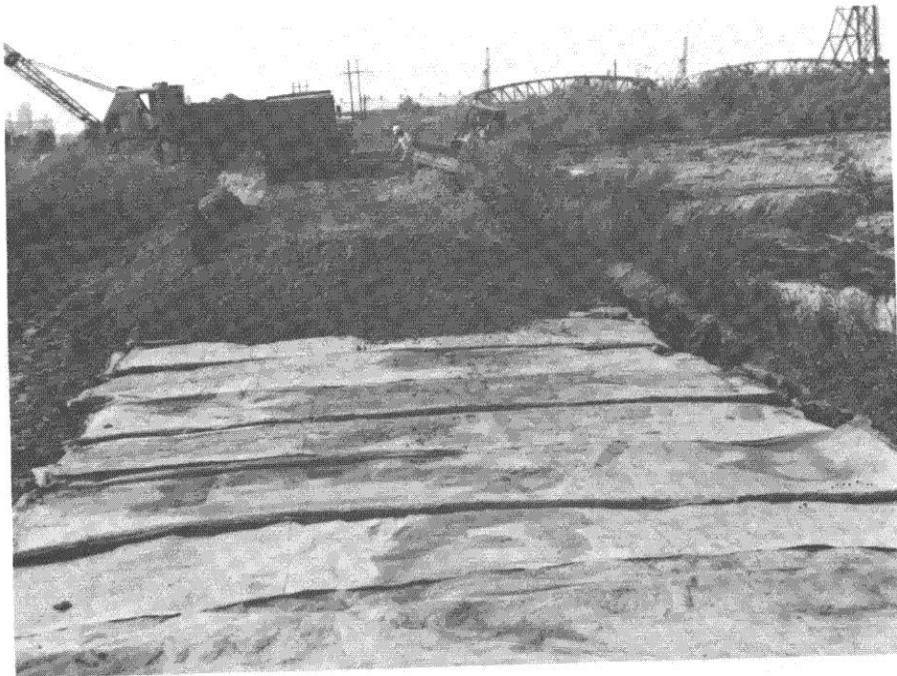
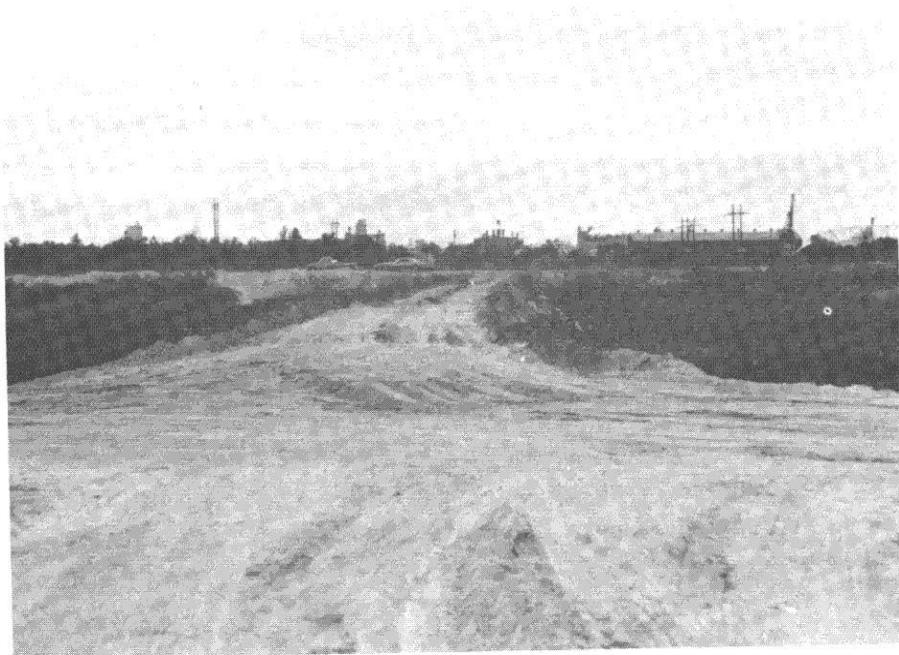
a. Cement waste evaluated as road surfacing is shown being placed on the fabric-covered subgrade. Note the resemblance of the partially hydrated cement waste to sand

b. Condition of cement waste surface on spur haul road after approximately 400 load repetitions

Figure 14. Details of haul road surfacing with cement waste

47. Figure 14a shows the cement waste being placed on the ALCOA-provided filter fabric. Initial attempts at dozer-track compacting this material in a dry state were essentially unsuccessful. Some attempts were made to haul water to the material in the contractor's dump trucks; these attempts were only partially successful. The most successful construction technique for compaction

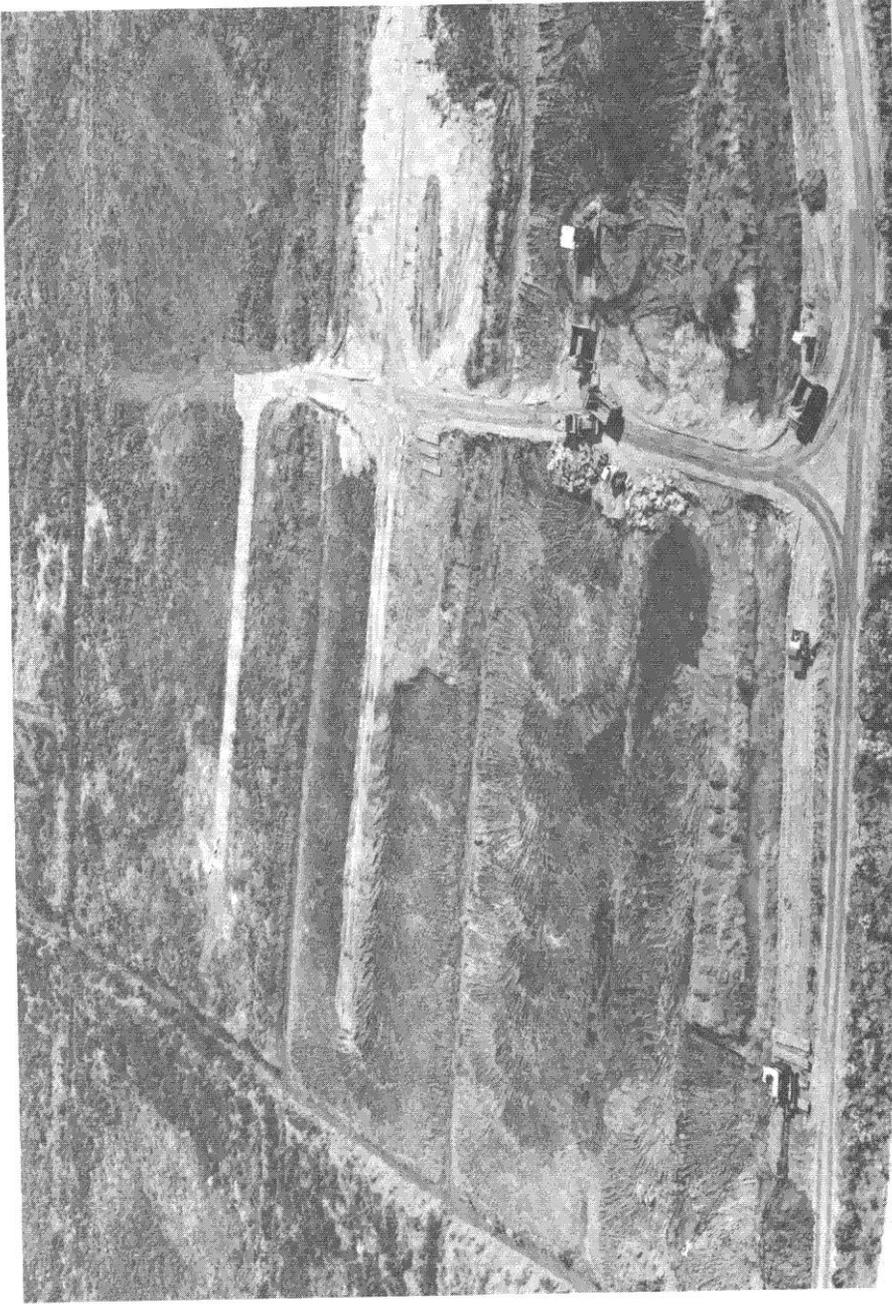
Figure 15. Aerial view of interior borrow area looking east. Note main west-east haul road entering roadway from existing dike crest. The first spur haul road in the left corner of the photograph has already been removed, along with the borrowed crust. Partial borrow operations have been conducted along the second spur haul road and the dragline is currently removing the other arm of the first spur haul road. Also seen in the photograph are a completed haul road spur, not yet in use, in the right center of the photograph and fabric placed for a third haul road spur in the upper center of the photograph. The subgrade pad established for the main haul road may be seen as an extension of the existing main haul road in the upper part of the photo

48. Figure 15 is an aerial view of the haul road area. As may be noted from the photograph, material has been removed from the lower left portion of the photograph and the spur haul road that extended into this area has also been removed. Borrow removal has taken place along one haul road, and another haul road is being removed. An already constructed but not yet used haul road may also be seen in the photograph, as well as fabric placed for another spur haul road.

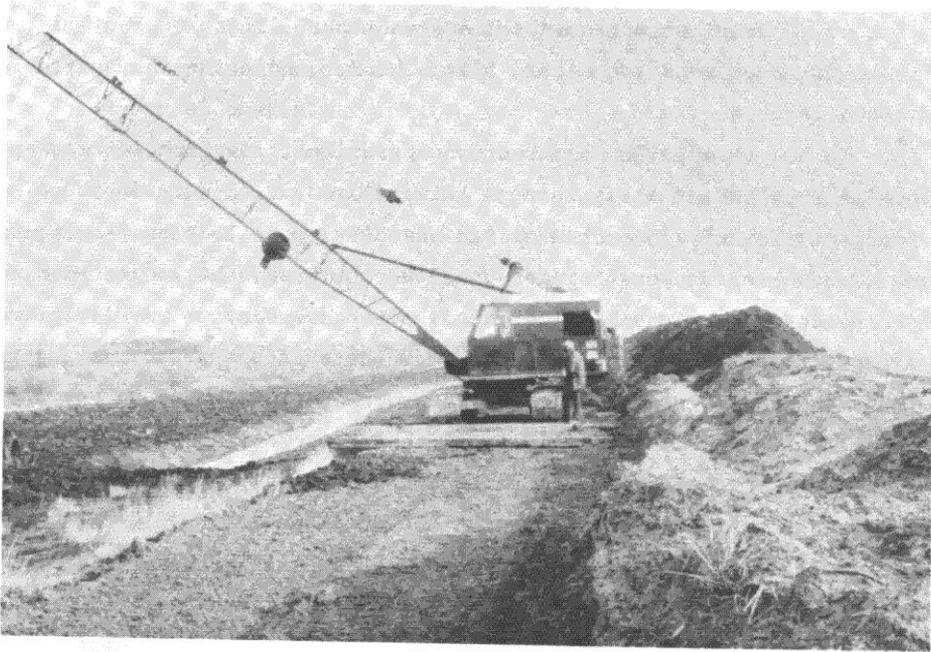
Figure 16. Large dragline shown removing crust from inside perimeter of east dike. Crust bench under dragline mats will be used for construction of second lift. Note mounds of borrow along alignment placed by previous truck haulage from interior borrow area. Small dragline is shown in background placing second lift in long partial segment construction

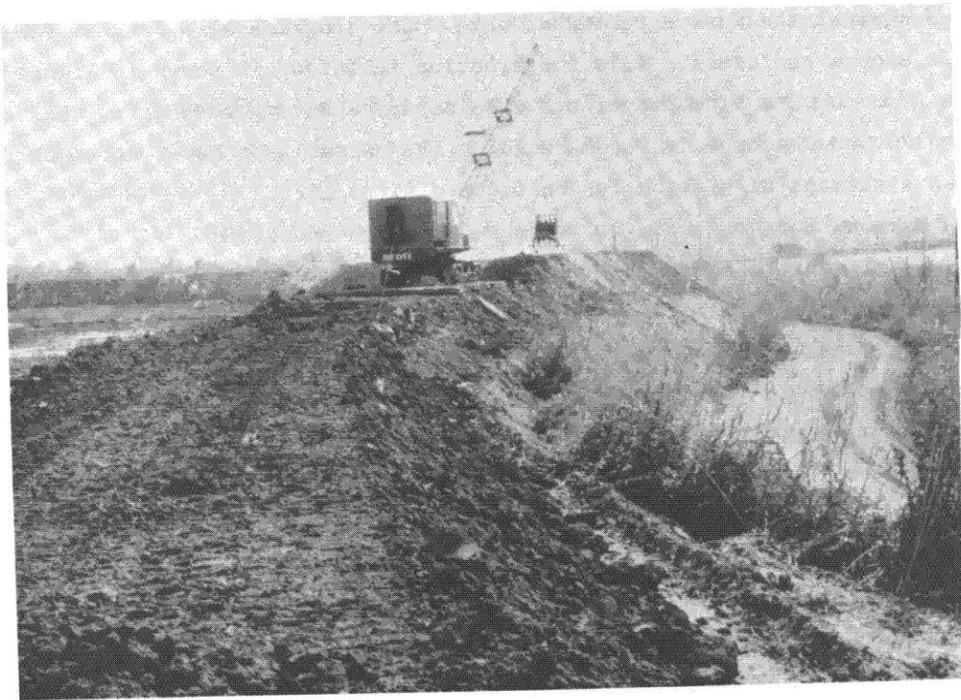
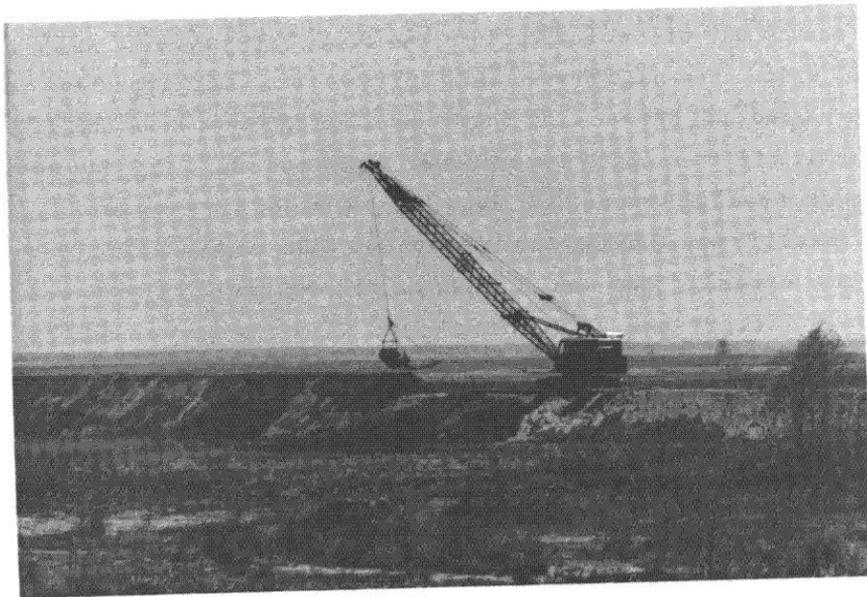
a. Dragline is shown completing first lift along east dike. Borrow in foreground has been roughly shaped by dozer to facilitate precipitation runoff. Ragging on stake in center of photograph indicates El. 20 MSL, crest elevation for first raise lift

b. After initial construction, the second lift was placed and crest and side slopes dressed by the dragline

Figure 17. Long partial segment dike construction method

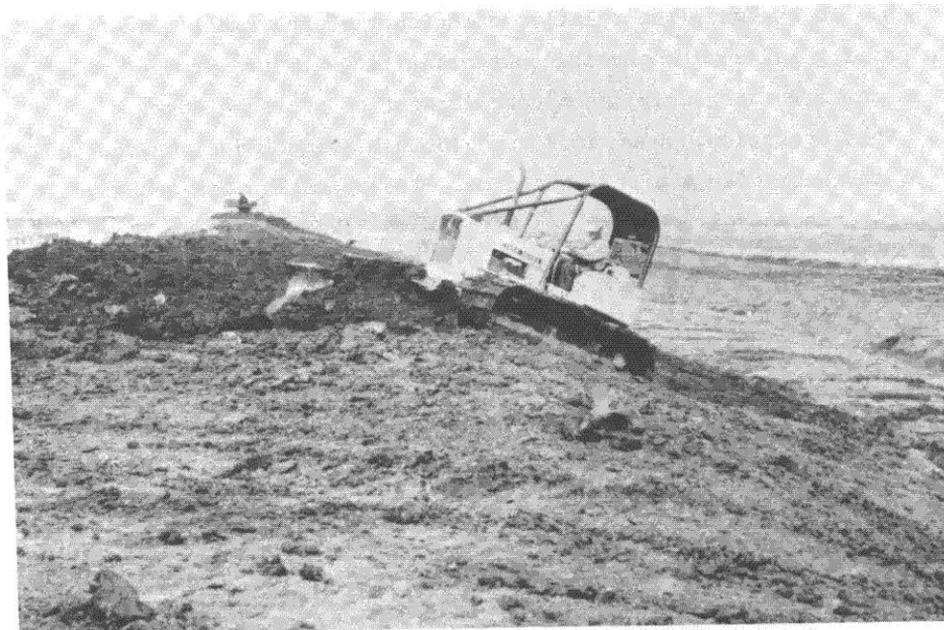
Figure 18. Small wide-track dozer shown constructing first lift while dragline in background of photograph constructs second lift and dresses the crest and side slopes

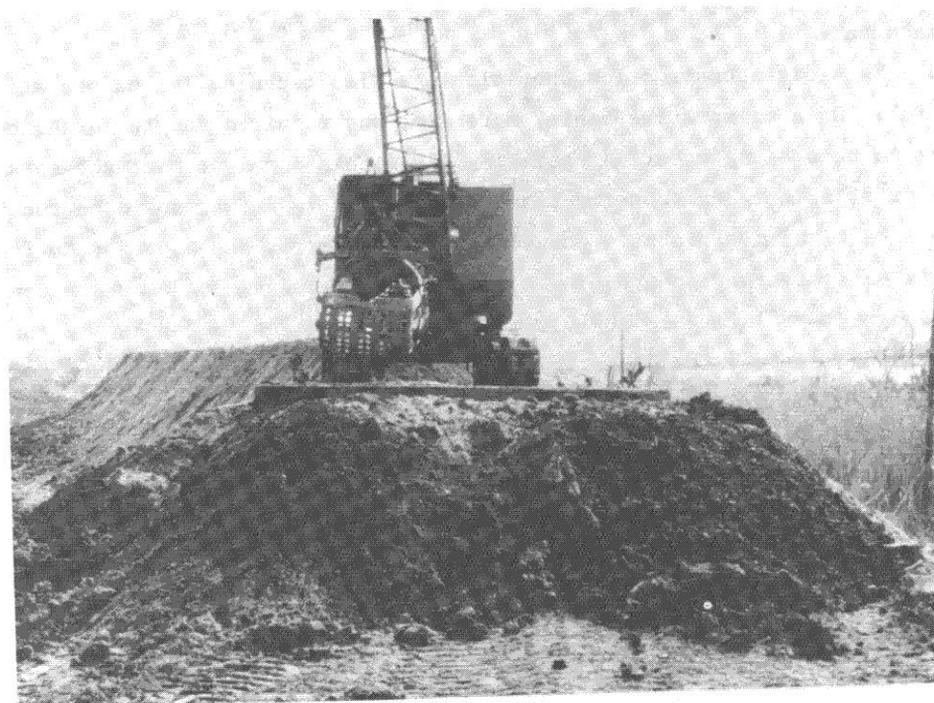
Figure 19. In the sequential dike construction technique, the dragline constructs the first lift ahead for a short distance, then rotates its boom and constructs the second lift behind, while moving down the dike alignment

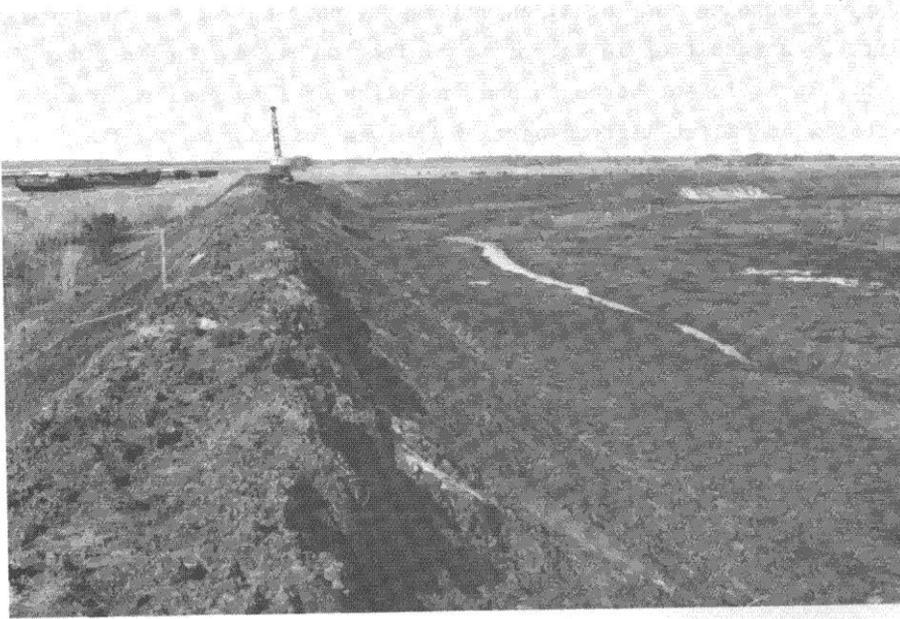
Figure 20. Rain-induced sloughing and sliding of uncompacted second lift. Note rotational slumping on inside slope with crest subsidence. Underlying semicompacted first lift was not affected

a. Sloughing and localized sliding by portions of the newly placed second lift, as a result of 10 in. of precipitation received over 2 days.

65. After approximately 4,000 lin ft of finished dike had been constructed, from the northeast corner of the site west along the north dike and south along the west dike, extremely heavy precipitation, amounting to more than 10 in. in 48 hr, fell over the disposal area. This heavy rainfall infiltrated portions of the uncompacted second lift in the vicinity of the northmost weir (Figure 5) and approximately 1,500 lin ft of the second lift suffered side slope erosion damage and generalized slope sloughing and sliding along both interior and exterior side slopes. The underlying semicompacted first lift was unaffected. The rain-induced damage is shown in Figure 20. Evaluation of this failure indicated that, when placing the second lift, the crest had not been crowned sufficiently to allow rapid precipitation runoff. Ponding thus occurred on the dike crest and resulting infiltration both increased the unit weight of the uncompacted second lift material and reduced its effective shear strength. Also, the ponded water velocity at these localized points produced erosion damage. At other locations along the dike where the second lift was in place with proper crown, the heavy precipitation ran off, with essentially minimal damage to the dike.

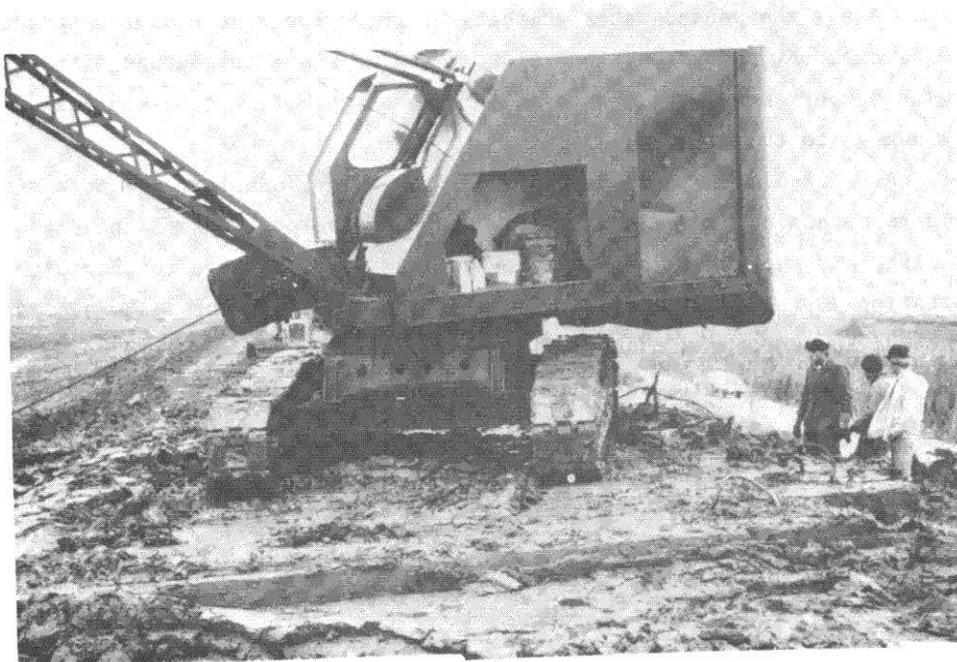
Figure 21. Dragline in mobility trouble on east dike caused from precipitation ponding and infiltration into previously place first lift

b. Insufficient strength and stability of fine-grained dredged material borrow and first lift on part of the west dike as a result of precipitation ponding and infiltration.

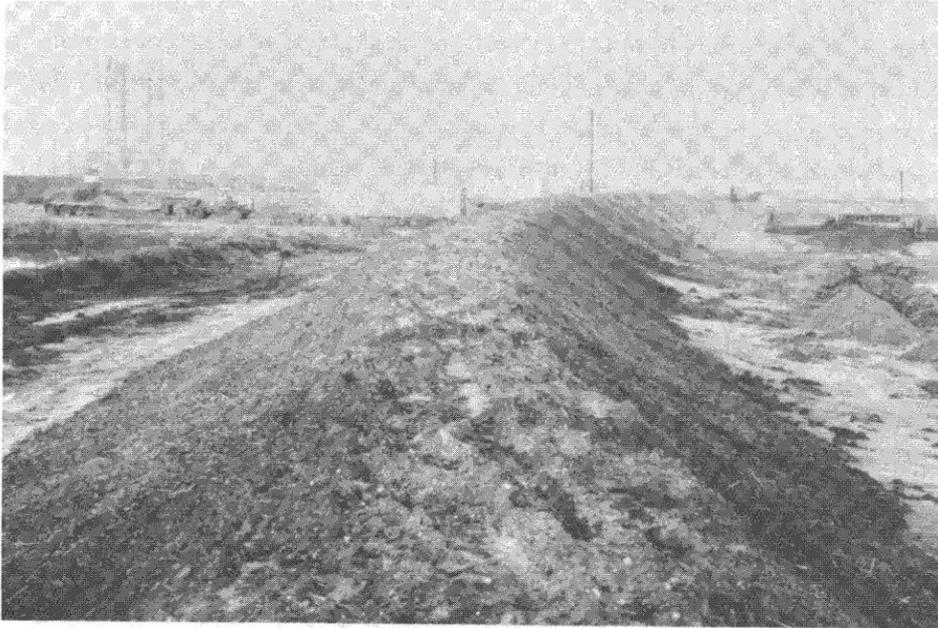
Figure 22. Dike segment of essentially coarse-grained material constructed between east dike and DOP underdrainage experiment location. View looking east from the east dike toward the DOP underdrainage experiment. Note traces of snow on the embankment

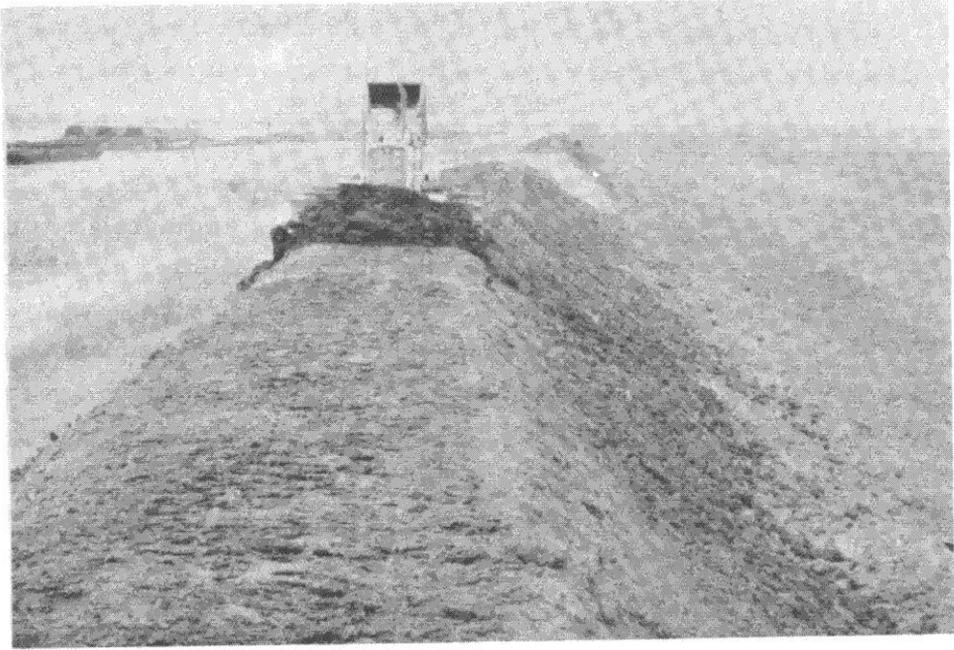
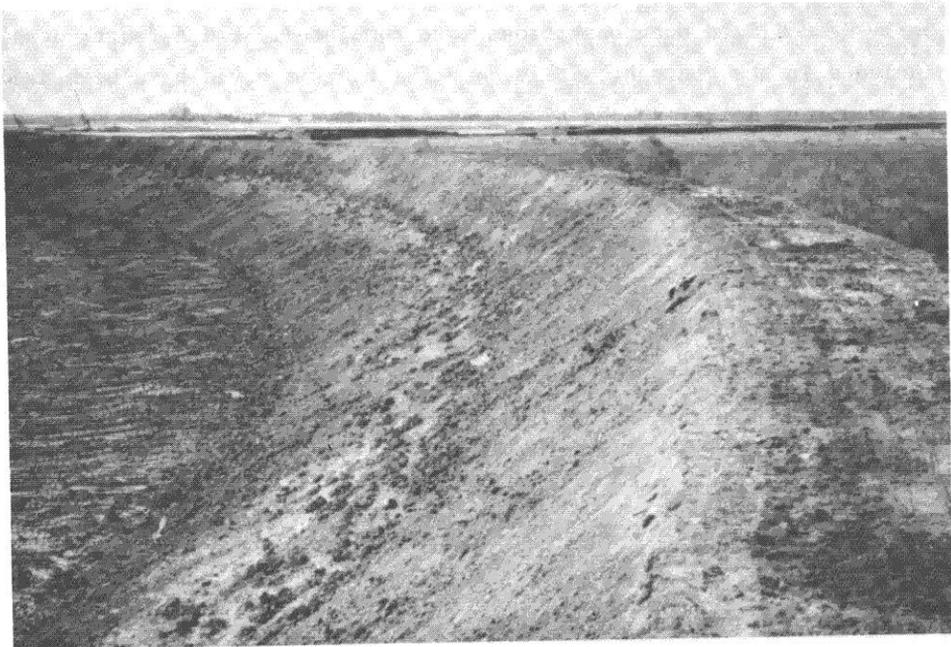
a. As the last construction operation, the small wide-track dozer bladed the dike to 8-ft crest width at El. 24 MSL

b. View of the completed raised perimeter dike

Figure 23. Completion of perimeter dike raising
